Access Compliance Report

Public Rights-of-Way

(Curb Ramps)

Intersection ID: 18423	Main Street: ELESSAR_PL	Cross Street: STRIDER_DR	Location: NW
ADA ID: 806C8788EC15	Ramp Type: PerpDiag	Initial Pass/Fail: Fail	Overall Compliance: No
Severity Score: 12.5			
Codes/Mitigation Info/Possible Solution		Field Measurements/Component Compliance

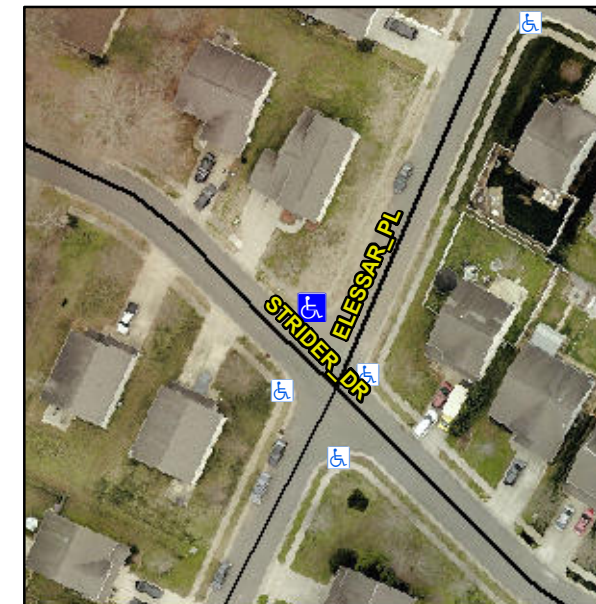
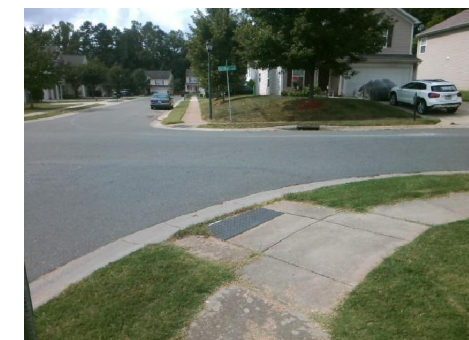
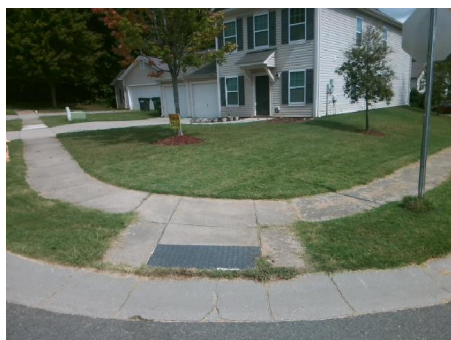
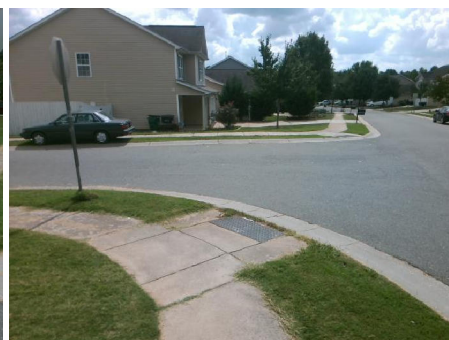
Compliance	Description	Data	Compliance	Description	Data
N/A	Ramp Length (in)	48.0	Yes	Ramp Slope (%)	6.0
Yes	Ramp Width (in)	48.0	No	Ramp XSlope (%)	5.7
N/A	Flare Type LT	N/A	N/A	Flare Type RT	N/A
N/A	Flare Slope LT (%)	N/A	N/A	Flare Slope RT (%)	N/A
N/A	Flare Traversable LT?	N/A	N/A	Flare Traversable RT?	N/A
N/A	Landing Length (in)	N/A	N/A	DWS Provided?	N/A
N/A	Landing Width (in)	N/A	N/A	DWS Contrast?	N/A
N/A	Landing Slope (%)	N/A	N/A	DWS Length (in)	N/A
N/A	Landing X Slope (%)	N/A	N/A	DWS Full Width?	N/A
N/A	Landing Curb? (Y/N)	N/A	N/A	DWS Offset (in)	N/A
N/A	Shared Landing?	N/A			
N/A	Gutter Ponding?	N/A	N/A	Gutter Slope (%)	N/A
N/A	Gutter Lip Ht (in)	N/A	N/A	Gutter X Slope (%)	N/A
N/A	Painted X Walk1?	No	N/A	Painted X Walk2?	No
	X Walk 1 Direction	To SW		X Walk 2 Direction	To SE
N/A	X Walk 1 Width (in)	N/A	N/A	X Walk 2 Width (in)	N/A
	X Walk 1 Slope (%)	2.1		X Walk 2 Slope (%)	0.5
	X Walk 1 X Slope (%)	5.1		X Walk 2 X Slope (%)	2.0

N/A	Ramp inside XWalk1?	N/A	N/A	Ramp inside XWalk2?	N/A
	Road Slope (%)	3.0	N/A	Clear Space?	N/A
	Road X Slope (%)	0.4	N/A	Clear Space to XWalk (in)	N/A
N/A	Any Obstructions?	N/A	N/A	Storm Grate/Utility Hazard?	N/A
	Obstruction Type			Storm Grate/Utility Type	
		N/A			N/A
		Yes		Surface Condition? (G/P)	Good

Remove & Replace Curb Ramp With Two New Directional Ramps or Equivalent.

Not Found, R304.5.3
