Access Compliance Report

Public Rights-of-Way

(Curb Ramps)

Intersection ID: 54114	Main Street: ENDAHVEN_LN	Cross Street: ENDAHVEN_VILLAGE_DR	Location: SW
ADA ID: 80731A51B5DB	Ramp Type: PerpDiag	Initial Pass/Fail: Fail	Overall Compliance: No
Codes/Mitigation Info/Possible Solution		Field Measurements/Component Compliance	
Severity Score: 21.25

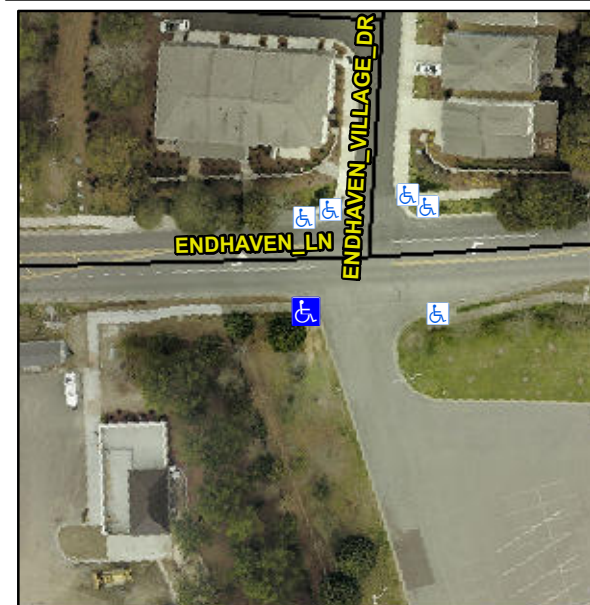
Compliance	Description	Data	Compliance	Description	Data
N/A	Ramp Length (in)	60.0	Yes	Ramp Slope (%)	5.1
No	Ramp Width (in)	44.0	No	Ramp XSlope (%)	5.3
N/A	Flare Type LT	N/A	N/A	Flare Type RT	N/A
N/A	Flare Slope LT (%)	N/A	N/A	Flare Slope RT (%)	N/A
N/A	Flare Traversable LT?	N/A	N/A	Flare Traversable RT?	N/A
N/A	Landing Length (in)	N/A	N/A	DWS Provided?	N/A
N/A	Landing Width (in)	N/A	N/A	DWS Contrast?	N/A
N/A	Landing Slope (%)	N/A	N/A	DWS Length (in)	N/A
N/A	Landing X Slope (%)	N/A	N/A	DWS Full Width?	N/A
N/A	Landing Curb? (Y/N)	N/A	N/A	DWS Offset (in)	N/A
N/A	Shared Landing?	N/A			
N/A	Gutter Ponding?	N/A	N/A	Gutter Slope (%)	N/A
N/A	Gutter Lip Ht (in)	N/A	N/A	Gutter X Slope (%)	N/A
N/A	Painted X Walk1?	No	N/A	Painted X Walk2?	No
	X Walk 1 Direction	To E		X Walk 2 Direction	To N
N/A	X Walk 1 Width (in)	N/A	N/A	X Walk 2 Width (in)	N/A
	X Walk 1 Slope (%)	2.0		X Walk 2 Slope (%)	2.5
	X Walk 1 X Slope (%)	3.5		X Walk 2 X Slope (%)	3.2

N/A	Ramp inside XWalk1?	N/A	N/A	Ramp inside XWalk2?	N/A
	Road Slope (%)	3.9	N/A	Clear Space?	N/A
	Road X Slope (%)	0.1	N/A	Clear Space to XWalk (in)	N/A
N/A	Any Obstructions?	N/A	N/A	Storm Grate/Utility Hazard?	N/A
	Obstruction Type			Storm Grate/Utility Type	
		N/A			N/A
			Yes	Surface Condition? (G/P)	Good

Possible Solutions:

Remove & Replace Curb Ramp With Two New Directional Ramps or Equivalent.

R304.5.1, R304.5.3

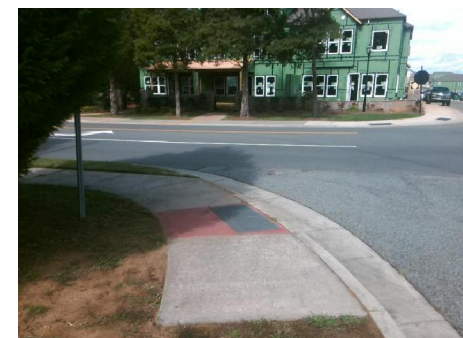
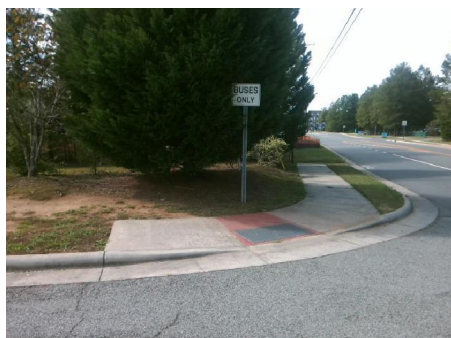
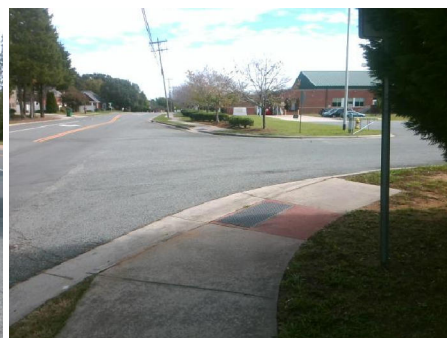
Street 1 Name **ENDHAVEN VILLAGE DR**
 Stop Condition-Street 2 **StopSign**
 Street 2 Name **ENDHAVEN LN**
 Stop Condition-Street 1 **None**
