# Access Compliance Report

## Public Rights-of-Way

### (Curb Ramps)

Intersection ID: 23352	Main Street: LANCER_DR	Cross Street: KNIGHTSWOOD_DR	Location:	N
ADA ID: 8074C24D5875	Ramp Type: Perp	Initial Pass/Fail: Fail	Overall Compliance: No	Severity Score: 25

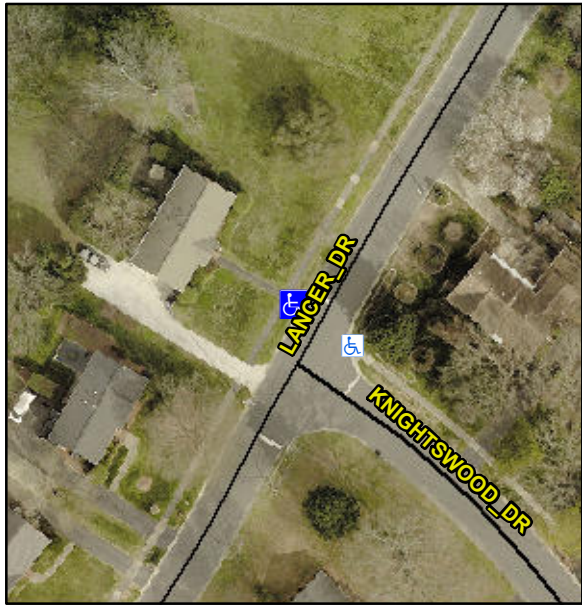
Possible Solutions:		Compliance	Description	Data	Compliance	Description	Data
	Remove & Replace Entire Ramp.		N/A	Ramp Length (in)	84.0	Yes	Ramp Slope (%)	7.2
			Yes	Ramp Width (in)	48.0	No	Ramp XSlope (%)	7.5
			N/A	Flare Type LT	N/A	N/A	Flare Type RT	N/A
			N/A	Flare Slope LT (%)	N/A	N/A	Flare Slope RT (%)	N/A
			N/A	Flare Traversable LT?	N/A	N/A	Flare Traversable RT?	N/A
			N/A	Landing Length (in)	N/A	N/A	DWS Provided?	N/A
			N/A	Landing Width (in)	N/A	N/A	DWS Contrast?	N/A
			N/A	Landing Slope (%)	N/A	N/A	DWS Length (in)	N/A
			N/A	Landing X Slope (%)	N/A	N/A	DWS Full Width?	N/A
Surveyor Notes:			N/A	Landing Curb? (Y/N)	N/A	N/A	DWS Offset (in)	N/A
N/A			N/A	Shared Landing?	N/A			
PROW/ADA:			N/A	Gutter Ponding?	N/A	N/A	Gutter Slope (%)	N/A
Not Found, R304.5.3			N/A	Gutter Lip Ht (in)	N/A	N/A	Gutter X Slope (%)	N/A

N/A	Painted X Walk1?	No	N/A	Painted X Walk2?	N/A
				X Walk 1 Direction	To SE		X Walk 2 Direction	N/A
			N/A	X Walk 1 Width (in)	N/A	N/A	X Walk 2 Width (in)	N/A
				X Walk 1 Slope (%)	4.9		X Walk 2 Slope (%)	N/A
				X Walk 1 X Slope (%)	6.7		X Walk 2 X Slope (%)	N/A
			N/A	Ramp inside XWalk1?	N/A	N/A	Ramp inside XWalk2?	N/A
				Road Slope (%)	N/A	N/A	Clear Space?	N/A
				Road X Slope (%)	N/A	N/A	Clear Space to XWalk (in)	N/A
			N/A	Any Obstructions?	N/A	N/A	Storm Grate/Utility Hazard?	N/A
				Obstruction Type			Storm Grate/Utility Type	
						N/A		N/A
						Yes	Surface Condition? (G/P)	Good
Total Cost:		\$ 1850.00
