Access Compliance Report

Public Rights-of-Way

(Curb Ramps)

Intersection ID: 13635	Main Street: E_BLAND_ST	Cross Street: SOUTH_BV	Location: NW
ADA ID: 8077E1AD407E	Ramp Type: Perp	Initial Pass/Fail: Fail	Overall Compliance: No
Severity Score: 46.25			
Codes/Mitigation Info/Possible Solution		Field Measurements/Component Compliance

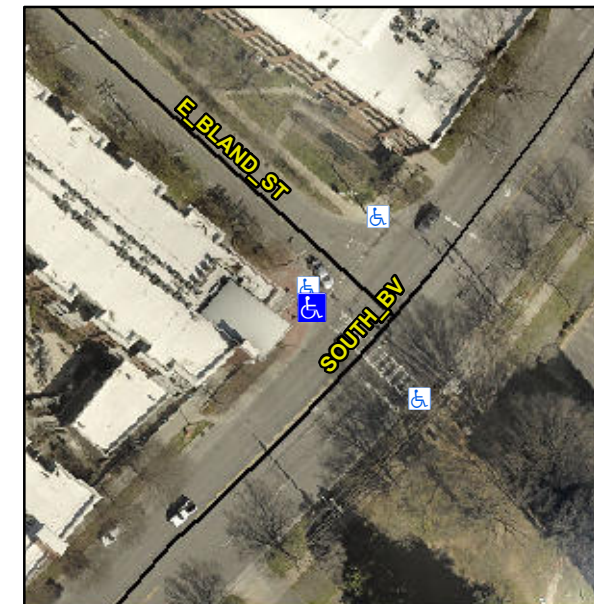
R304.5.1, R304.2.2, R304.5.3

Compliance	Description	Data	Compliance	Description	Data
N/A	Ramp Length (in)	89.0	No	Ramp Slope (%)	8.5
No	Ramp Width (in)	41.0	No	Ramp XSlope (%)	8.3
N/A	Flare Type LT	N/A	N/A	Flare Type RT	N/A
N/A	Flare Slope LT (%)	N/A	N/A	Flare Slope RT (%)	N/A
N/A	Flare Traversable LT?	N/A	N/A	Flare Traversable RT?	N/A
N/A	Landing Length (in)	N/A	N/A	DWS Provided?	N/A
N/A	Landing Width (in)	N/A	N/A	DWS Contrast?	N/A
N/A	Landing Slope (%)	N/A	N/A	DWS Length (in)	N/A
N/A	Landing X Slope (%)	N/A	N/A	DWS Full Width?	N/A
N/A	Landing Curb? (Y/N)	N/A	N/A	DWS Offset (in)	N/A
N/A	Shared Landing?	N/A			
N/A	Gutter Ponding?	N/A	N/A	Gutter Slope (%)	N/A
N/A	Gutter Lip Ht (in)	N/A	N/A	Gutter X Slope (%)	N/A
N/A	Painted X Walk1?	Yes	N/A	Painted X Walk2?	N/A
	X Walk 1 Direction	To SE		X Walk 2 Direction	N/A
N/A	X Walk 1 Width (in)	109.0	N/A	X Walk 2 Width (in)	N/A
	X Walk 1 Slope (%)	3.2		X Walk 2 Slope (%)	N/A
	X Walk 1 X Slope (%)	2.1		X Walk 2 X Slope (%)	N/A

N/A	Ramp inside XWalk1?	Yes	N/A	Ramp inside XWalk2?	N/A
	Road Slope (%)	N/A	N/A	Clear Space?	N/A
	Road X Slope (%)	N/A	N/A	Clear Space to XWalk (in)	N/A
N/A	Any Obstructions?	N/A	N/A	Storm Grate/Utility Hazard?	N/A
	Obstruction Type			Storm Grate/Utility Type	
		N/A			N/A
			Yes	Surface Condition? (G/P)	Good

Possible Solutions:

Remove & Replace Entire Ramp.
