Access Compliance Report

Public Rights-of-Way

(Curb Ramps)

Intersection ID: 14022	Main Street: HAWKINS_ST	Cross Street: W_WORTHINGTON_AV	Location: S
ADA ID: 807BE45B3D9C	Ramp Type: PerpDiag	Initial Pass/Fail: Fail	Overall Compliance: No
		Severity Score: 1.25

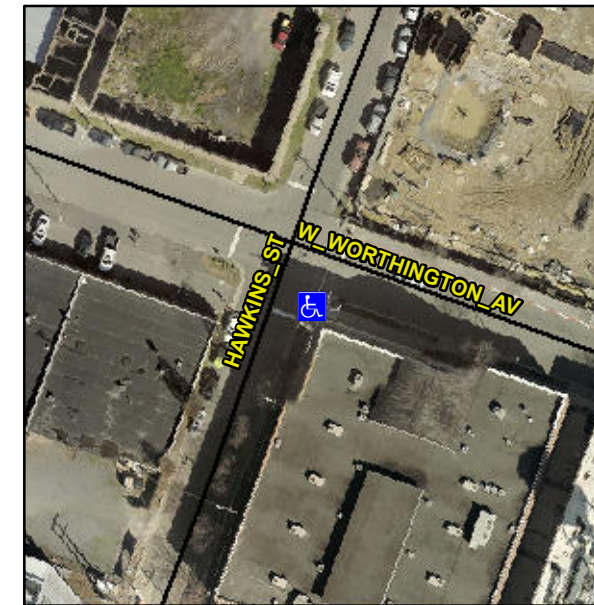
Not Found, R304.5.3

Compliance	Description	Data	Compliance	Description	Data
N/A	Ramp Length (in)	48.0	Yes	Ramp Slope (%)	5.1
Yes	Ramp Width (in)	48.0	No	Ramp XSlope (%)	2.2
N/A	Flare Type LT	N/A	N/A	Flare Type RT	N/A
N/A	Flare Slope LT (%)	N/A	N/A	Flare Slope RT (%)	N/A
N/A	Flare Traversable LT?	N/A	N/A	Flare Traversable RT?	N/A
N/A	Landing Length (in)	N/A	N/A	DWS Provided?	N/A
N/A	Landing Width (in)	N/A	N/A	DWS Contrast?	N/A
N/A	Landing Slope (%)	N/A	N/A	DWS Length (in)	N/A
N/A	Landing X Slope (%)	N/A	N/A	DWS Full Width?	N/A
N/A	Landing Curb? (Y/N)	N/A	N/A	DWS Offset (in)	N/A
N/A	Shared Landing?	N/A			
N/A	Gutter Ponding?	N/A	N/A	Gutter Slope (%)	N/A
N/A	Gutter Lip Ht (in)	N/A	N/A	Gutter X Slope (%)	N/A
N/A	Painted X Walk1?	No	N/A	Painted X Walk2?	No
	X Walk 1 Direction	To NE		X Walk 2 Direction	To NW
N/A	X Walk 1 Width (in)	N/A	N/A	X Walk 2 Width (in)	N/A
	X Walk 1 Slope (%)	2.6		X Walk 2 Slope (%)	0.6
	X Walk 1 X Slope (%)	1.5		X Walk 2 X Slope (%)	2.3

N/A	Ramp inside XWalk1?	N/A	N/A	Ramp inside XWalk2?	N/A
	Road Slope (%)	0.8	N/A	Clear Space?	N/A
	Road X Slope (%)	3.2	N/A	Clear Space to XWalk (in)	N/A
N/A	Any Obstructions?	N/A	N/A	Storm Grate/Utility Hazard?	N/A
	Obstruction Type			Storm Grate/Utility Type	
		N/A			N/A
			Yes	Surface Condition? (G/P)	Good

Remove & Replace Curb Ramp With Two New Directional Ramps or Equivalent.
