# Access Compliance Report

## Public Rights-of-Way

| Intersection ID: 46695 | Main Street: GOLDFIELDS_DR | Cross Street: TROTTERS_RIDGE_RD | Location: SW |
| ADA ID: 807E2EFA8628 | Ramp Type: PerpDiag | Initial Pass/Fail: Fail | Overall Compliance: No |

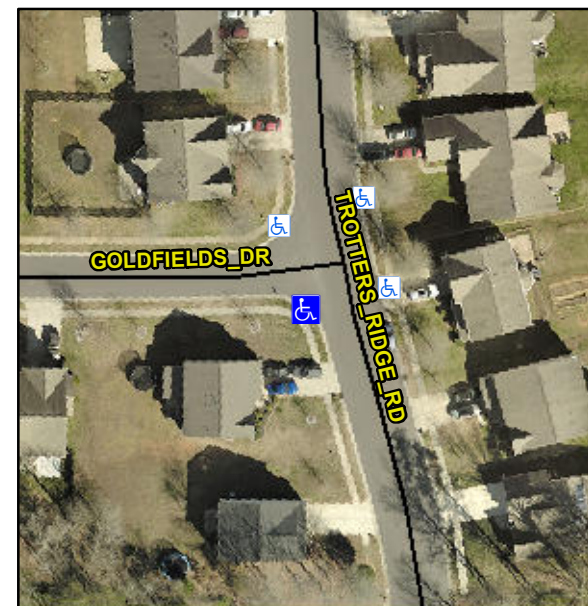
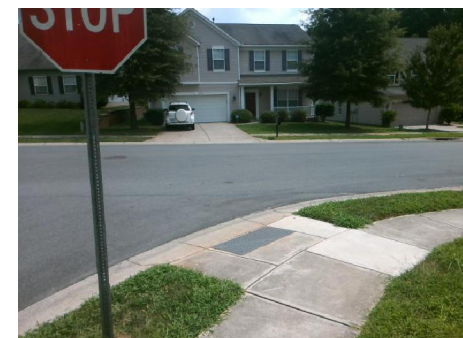
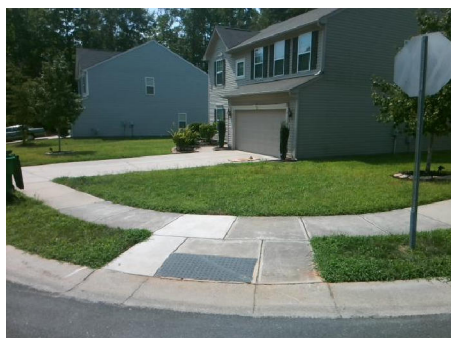
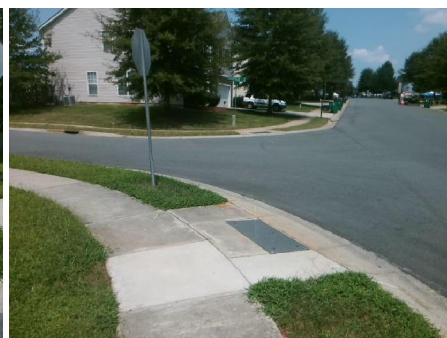
| Compliance | Description | Data | Compliance | Description | Data |
|---|---|---|---|---|---|
| N/A | Ramp Length (in) | 47.0 | No | Ramp Slope (%) | 9.9 |
| No | Ramp Width (in) | 46.0 | No | Ramp XSlope (%) | 3.1 |
| | | | Yes | Surface Condition? (G/P) | Good |

**Remove & Replace Curb Ramp With Two New Directional Ramps or Equivalent.**

**R304.5.1, R304.2.2, R304.5.3**
