# Access Compliance Report

## Public Rights-of-Way

Intersection ID: 10319	Main Street: BACON_AV	Cross Street: ROZZELLES_FERRY_RD	Location: NE
ADA ID: 808B89383699	Ramp Type: PerpDiag	Initial Pass/Fail: Fail	Overall Compliance: No
		Severity Score: 22.5

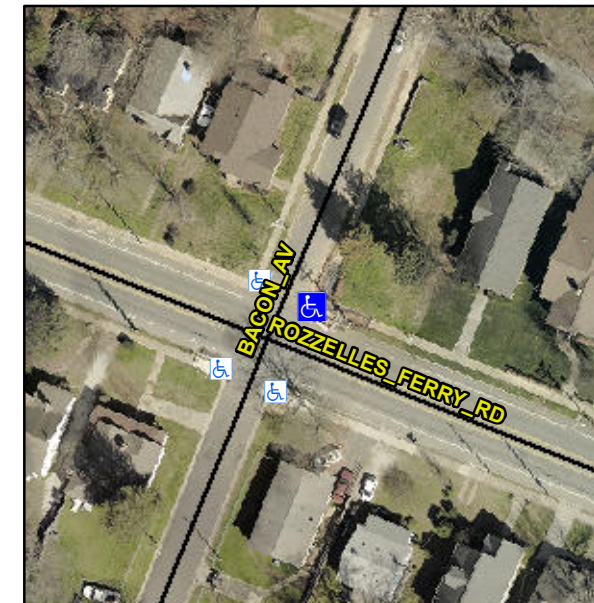
**Not Found, R304.5.1, R304.2.2, R304.5.3**

Compliance	Description	Data	Compliance	Description	Data
N/A	Ramp Length (in)	46.0	No	Ramp Slope (%)	10.1
No	Ramp Width (in)	38.0	No	Ramp XSlope (%)	2.3
N/A	Flare Type LT	N/A	N/A	Flare Type RT	N/A
N/A	Flare Slope LT (%)	N/A	N/A	Flare Slope RT (%)	N/A
N/A	Flare Traversable LT?	N/A	N/A	Flare Traversable RT?	N/A
N/A	Landing Length (in)	N/A	N/A	DWS Provided?	N/A
N/A	Landing Width (in)	N/A	N/A	DWS Contrast?	N/A
N/A	Landing Slope (%)	N/A	N/A	DWS Length (in)	N/A
N/A	Landing X Slope (%)	N/A	N/A	DWS Full Width?	N/A
N/A	Landing Curb? (Y/N)	N/A	N/A	DWS Offset (in)	N/A
N/A	Shared Landing?	N/A			
N/A	Gutter Ponding?	N/A	N/A	Gutter Slope (%)	N/A
N/A	Gutter Lip Ht (in)	N/A	N/A	Gutter X Slope (%)	N/A
N/A	Painted X Walk1?	No	N/A	Painted X Walk2?	No
	X Walk 1 Direction	To NW		X Walk 2 Direction	To SW
N/A	X Walk 1 Width (in)	N/A	N/A	X Walk 2 Width (in)	N/A
	X Walk 1 Slope (%)	0.8		X Walk 2 Slope (%)	10.2
	X Walk 1 X Slope (%)	1.4		X Walk 2 X Slope (%)	1.0

N/A	Ramp inside XWalk1?	N/A	N/A	Ramp inside XWalk2?	N/A
	Road Slope (%)	1.9	N/A	Clear Space?	N/A
	Road X Slope (%)	4.7	N/A	Clear Space to XWalk (in)	N/A
N/A	Any Obstructions?	N/A	N/A	Storm Grate/Utility Hazard?	N/A
	Obstruction Type			Storm Grate/Utility Type	
		N/A			N/A
			Yes	Surface Condition? (G/P)	Good

**Remove & Replace Curb Ramp With Two New Directional Ramps or Equivalent.**
