Access Compliance Report

Public Rights-of-Way

(Curb Ramps)

Intersection ID: 45885	Main Street: ETHEL_CT	Cross Street: BEN_LIVINGSTON_RD	Location: E
ADA ID: 808F1A9E103A	Ramp Type: PerpDiag	Initial Pass/Fail: Fail	Overall Compliance: No
Severity Score: 33.75			
Codes/Mitigation Info/Possible Solution		Field Measurements/Component Compliance

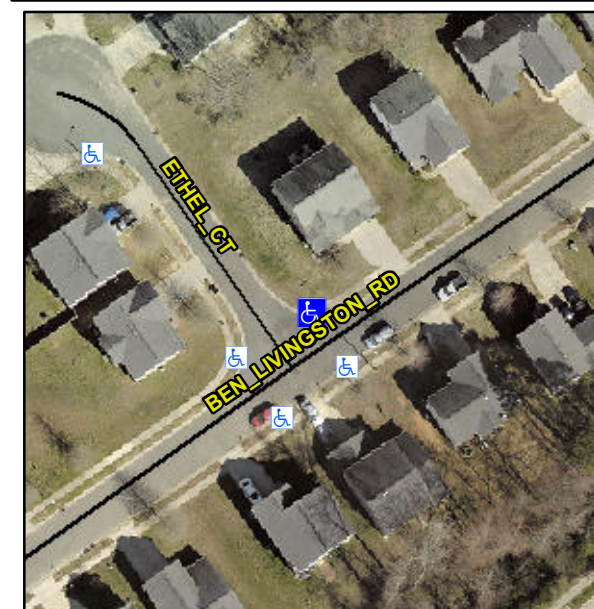
Compliance	Description	Data	Compliance	Description	Data
N/A	Ramp Length (in)	48.0	No	Ramp Slope (%)	10.4
No	Ramp Width (in)	43.0	No	Ramp XSlope (%)	6.6
N/A	Flare Type LT	N/A	N/A	Flare Type RT	N/A
N/A	Flare Slope LT (%)	N/A	N/A	Flare Slope RT (%)	N/A
N/A	Flare Traversable LT?	N/A	N/A	Flare Traversable RT?	N/A
N/A	Landing Length (in)	N/A	N/A	DWS Provided?	N/A
N/A	Landing Width (in)	N/A	N/A	DWS Contrast?	N/A
N/A	Landing Slope (%)	N/A	N/A	DWS Length (in)	N/A
N/A	Landing X Slope (%)	N/A	N/A	DWS Full Width?	N/A
N/A	Landing Curb? (Y/N)	N/A	N/A	DWS Offset (in)	N/A
N/A	Shared Landing?	N/A			
N/A	Gutter Ponding?	N/A	N/A	Gutter Slope (%)	N/A
N/A	Gutter Lip Ht (in)	0.5	N/A	Gutter X Slope (%)	N/A
N/A	Painted X Walk1?	No	N/A	Painted X Walk2?	No
	X Walk 1 Direction	To SW		X Walk 2 Direction	To SE
N/A	X Walk 1 Width (in)	N/A	N/A	X Walk 2 Width (in)	N/A
	X Walk 1 Slope (%)	4.9		X Walk 2 Slope (%)	4.7
	X Walk 1 X Slope (%)	4.2		X Walk 2 X Slope (%)	4.9

N/A	Ramp inside XWalk1?	N/A	N/A	Ramp inside XWalk2?	N/A
	Road Slope (%)	7.3	N/A	Clear Space?	N/A
	Road X Slope (%)	4.7	N/A	Clear Space to XWalk (in)	N/A
N/A	Any Obstructions?	N/A	N/A	Storm Grate/Utility Hazard?	N/A
	Obstruction Type			Storm Grate/Utility Type	
		N/A			N/A
			Yes	Surface Condition? (G/P)	Good

Possible Solutions:

Remove & Replace Curb Ramp With Two New Directional Ramps or Equivalent.
