Access Compliance Report

Public Rights-of-Way

(Curb Ramps)

Intersection ID: 9237	Main Street: REDBUD_ST	Cross Street: BOOKER_AV	Location: SE
ADA ID: 80965310C1A6	Ramp Type: PerpDiag	Initial Pass/Fail: Fail	Overall Compliance: No
Severity Score: 8.75			
Codes/Mitigation Info/Possible Solution		Field Measurements/Component Compliance

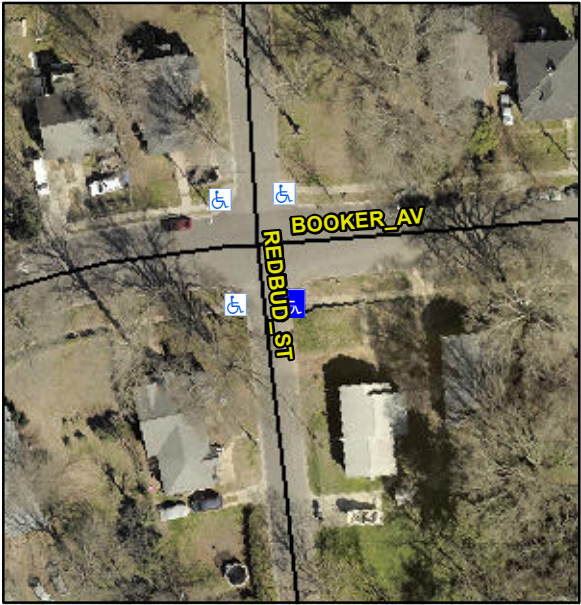
Possible Solutions:		Compliance		Description		Data	Compliance	Description	Data
	Remove & Replace Curb Ramp With Two New Directional Ramps or Equivalent.		N/A		Ramp Length (in)		59.0	Yes	Ramp Slope (%)	5.0
<p>Surveyor Notes:</p> <p>N/A</p> <p>PROW/ADA:</p> <p>Not Found, R304.5.1</p>			No		Ramp Width (in)		39.0	Yes	Ramp XSlope (%)	0.5
			N/A		Flare Type LT		N/A	N/A	Flare Type RT	N/A
			N/A		Flare Slope LT (%)		N/A	N/A	Flare Slope RT (%)	N/A
			N/A		Flare Traversable LT?		N/A	N/A	Flare Traversable RT?	N/A
			N/A		Landing Length (in)		N/A	N/A	DWS Provided?	N/A
			N/A		Landing Width (in)		N/A	N/A	DWS Contrast?	N/A
			N/A		Landing Slope (%)		N/A	N/A	DWS Length (in)	N/A
			N/A		Landing X Slope (%)		N/A	N/A	DWS Full Width?	N/A
			N/A		Landing Curb? (Y/N)		N/A	N/A	DWS Offset (in)	N/A
			N/A		Shared Landing?		N/A			
			N/A		Gutter Ponding?		N/A	N/A	Gutter Slope (%)	N/A
			N/A		Gutter Lip Ht (in)		N/A	N/A	Gutter X Slope (%)	N/A

N/A		Painted X Walk1?		No	N/A	Painted X Walk2?	No
					X Walk 1 Direction		To N		X Walk 2 Direction	To W
			N/A		X Walk 1 Width (in)		N/A	N/A	X Walk 2 Width (in)	N/A
					X Walk 1 Slope (%)		7.3		X Walk 2 Slope (%)	3.7
					X Walk 1 X Slope (%)		2.0		X Walk 2 X Slope (%)	1.6
			N/A		Ramp inside XWalk1?		N/A	N/A	Ramp inside XWalk2?	N/A
					Road Slope (%)		1.7	N/A	Clear Space?	N/A
					Road X Slope (%)		1.3	N/A	Clear Space to XWalk (in)	N/A
			N/A		Any Obstructions?		N/A	N/A	Storm Grate/Utility Hazard?	N/A
					Obstruction Type				Storm Grate/Utility Type	
								N/A		N/A
								Yes	Surface Condition? (G/P)	Good
