# Access Compliance Report

## Public Rights-of-Way

Intersection ID: 45067	Main Street: DARBYWINE_DR	Cross Street: FIFENDRUM_LN	Location: SW
ADA ID: 80A3B8356813	Ramp Type: BlendTrans1	Initial Pass/Fail: Fail	Overall Compliance: No
Severity Score: 25			
Codes/Mitigation Info/Possible Solution		Field Measurements/Component Compliance

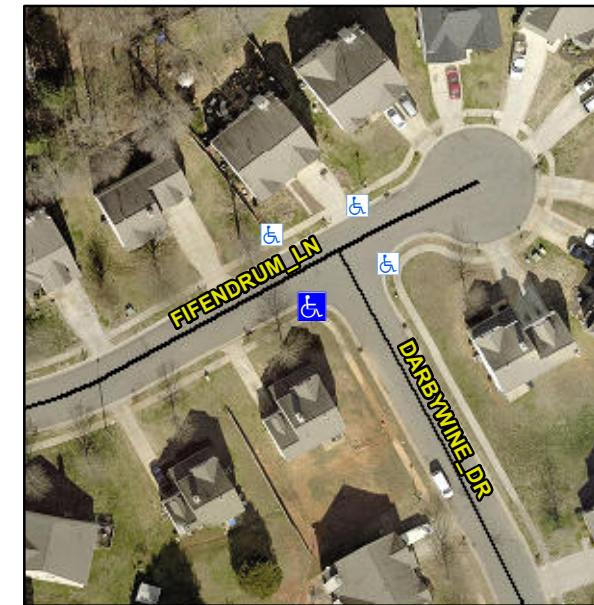
**Not Found, R304.5.3**

Compliance	Description	Data	Compliance	Description	Data
N/A	Ramp Length (in)	47.0	Yes	BlendTrans Slope (%)	2.9
Yes	Ramp Width (in)	48.0	No	BlendTrans XSlope (%)	13.6
N/A	Flare Type LT	N/A	N/A	Flare Type RT	N/A
N/A	Flare Slope LT (%)	N/A	N/A	Flare Slope RT (%)	N/A
N/A	Flare Traversable LT?	N/A	N/A	Flare Traversable RT?	N/A
N/A	Landing Length (in)	N/A	N/A	DWS Provided?	N/A
N/A	Landing Width (in)	N/A	N/A	DWS Contrast?	N/A
N/A	Landing Slope (%)	N/A	N/A	DWS Length (in)	N/A
N/A	Landing X Slope (%)	N/A	N/A	DWS Full Width?	N/A
N/A	Landing Curb? (Y/N)	N/A	N/A	DWS Offset (in)	N/A
N/A	Shared Landing?	N/A			
N/A	Gutter Ponding?	N/A	N/A	Gutter Slope (%)	N/A
N/A	Gutter Lip Ht (in)	N/A	N/A	Gutter X Slope (%)	N/A
N/A	Painted X Walk1?	No	N/A	Painted X Walk2?	No
	X Walk 1 Direction	To NE		X Walk 2 Direction	To N
	X Walk 1 Width (in)	N/A		X Walk 2 Width (in)	N/A
	X Walk 1 Slope (%)	7.5		X Walk 2 Slope (%)	3.0
	X Walk 1 X Slope (%)	2.1		X Walk 2 X Slope (%)	9.5

N/A	Ramp inside XWalk1?	N/A	N/A	Ramp inside XWalk2?	N/A
	Road Slope (%)	8.1		Clear Space?	N/A
	Road X Slope (%)	3.7	N/A	Clear Space to XWalk (in)	N/A
N/A	Any Obstructions?	N/A	N/A	Storm Grate/Utility Hazard?	N/A
	Obstruction Type			Storm Grate/Utility Type	
		N/A			N/A
			Yes	Surface Condition? (G/P)	Good
			No	Curb Slope (%)	8.8

**Remove & Replace Curb Ramp With Two New Directional Ramps or Equivalent.**

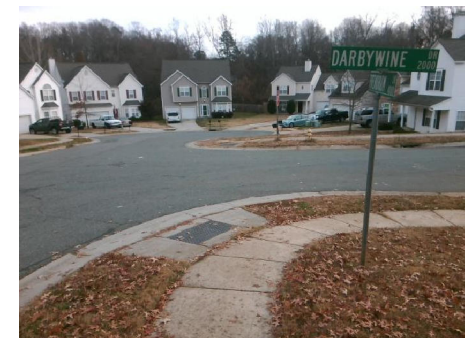
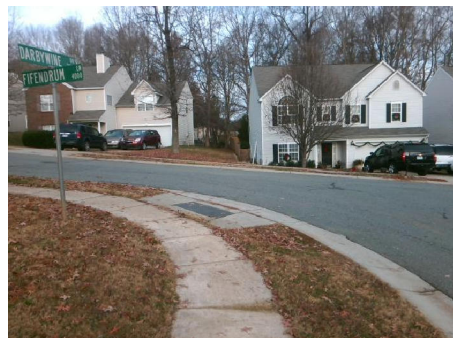
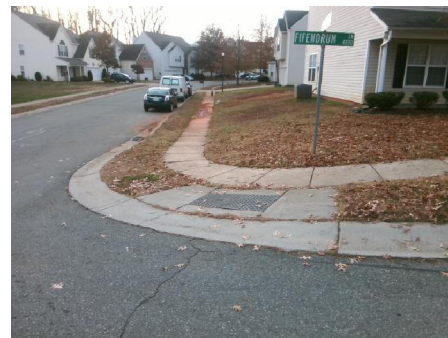
Street 1 Name **DARBYWINE DR**  
 Stop Condition-Street 1 **StopSign**  
 Street 2 Name **FIFENDRUM LN**  
 Stop Condition-Street 2 **None**
