Access Compliance Report Public Rights-of-Way (Curb Ramps)

Intersection ID: 25251 Main Street: JOHNSTON_RD Cross Street: OAKBROOK_DR Location: NW **Overall Compliance: No** ADA ID: 80A848256654 Ramp Type: Perp Initial Pass/Fail: Fail **Severity Score:** 25

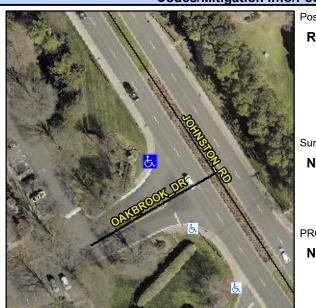
Field Measurements/Component Compliance							
Compliance Description		Data	Comp	liance	Description	Data	
N/A	Ramp Length (in)	60.0	No	Ramp	Slope (%)	9.2	
Yes	Ramp Width (in)	48.0	No	• Ramp XSlope (%)		5.1	
N/A	Flare Type LT	N/A	N/A	/A Flare Type RT		N/A	
N/A	Flare Slope LT (%)	N/A	N/A	Flare Slope RT (%)		N/A	
N/A	Flare Traversable LT?	N/A	N/A	Flare Traversable RT?		N/A	
N/A	Landing Length (in)	N/A	N/A	DWS Provided?		N/A	
N/A	Landing Width (in)	N/A	N/A	DWS Contrast?		N/A	
N/A	Landing Slope (%)	N/A	N/A	DWS	Length (in)	N/A	
N/A	Landing X Slope (%)	N/A	N/A	DWS	Full Width?	N/A	
N/A	Landing Curb? (Y/N)	N/A	N/A	DWS	Offset (in)	N/A	
N/A	Shared Landing?	N/A					
N/A	Gutter Ponding?	N/A	N/A	Gutte	r Slope (%)	N/A	
N/A	Gutter Lip Ht (in)	N/A	N/A	Gutte	r X Slope (%)	N/A	
N/A	Painted X Walk1?	No	N/A	Painte	ed X Walk2?	N/A	
	X Walk 1 Direction	To SE		X Wa	lk 2 Direction	N/A	
N/A	X Walk 1 Width (in)	N/A	N/A	X Wa	lk 2 Width (in)	N/A

X Walk 1 Slope (%)	1.9		X Wa	lk 2 Slope (%)	N/A	
	X Walk 1 X Slope (%)	4.1		X Wa	lk 2 X Slope (%)	N/A	
N/A	Ramp inside XWalk1?	N/A	N/A	Ramp	inside XWalk2?	N/A	
	Road Slope (%)	N/A	N/A	Clear	Space?	N/A	
	Road X Slope (%)	N/A	N/A	Clear	Space to XWalk (in)	N/A	
N/A	Any Obstructions?	N/A	N/A	Storm	Grate/Utility Hazard?	N/A	
	Obstruction Type			Storm	Grate/Utility Type		
		N/A				N/A	
			Yes	Surfa	ce Condition? (G/P)	Good	
V Was to

Possible Solutions:
Remove & Replace Entire Ramp.
Surveyor Notes:
N/A
N/A
PROW/ADA:
Not Found, R304.2.2, R304.5.3

Total Cost: 1850.00
