Access Compliance Report

Public Rights-of-Way

(Curb Ramps)

Intersection ID: 5566	Main Street: HANBERRY_BV	Cross Street: BACK_CREEK_CHURCH_RD	Location: S
ADA ID: 80A9B3009B6D	Ramp Type: PerpDiag	Initial Pass/Fail: Fail	Overall Compliance: No
Severity Score: 8.75			
Codes/Mitigation Info/Possible Solution		Field Measurements/Component Compliance

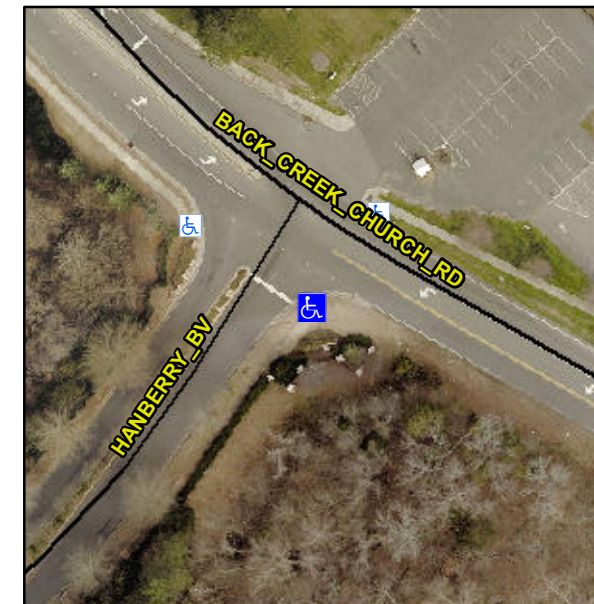
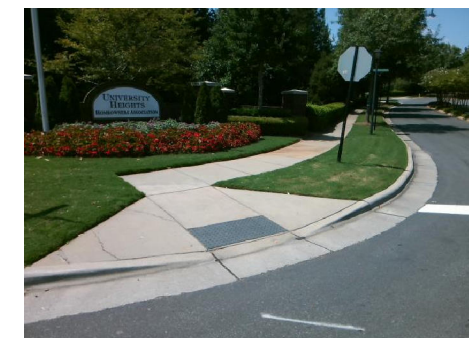
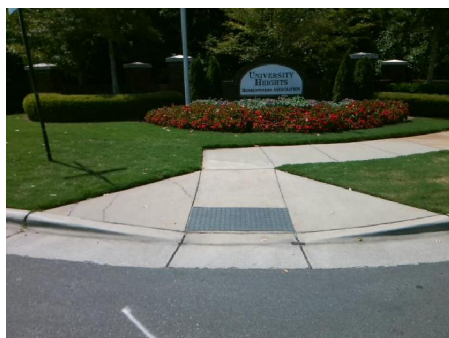
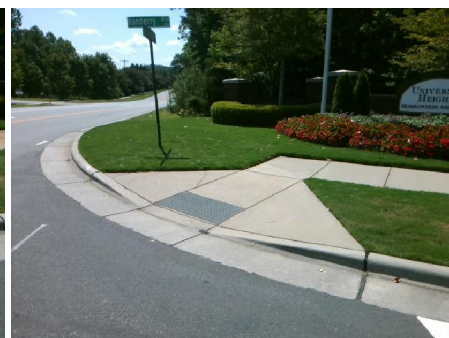
Not Found, R304.5.1

Compliance	Description	Data	Compliance	Description	Data
N/A	Ramp Length (in)	85.0	Yes	Ramp Slope (%)	7.2
No	Ramp Width (in)	47.0	Yes	Ramp XSlope (%)	1.4
N/A	Flare Type LT	N/A	N/A	Flare Type RT	N/A
N/A	Flare Slope LT (%)	N/A	N/A	Flare Slope RT (%)	N/A
N/A	Flare Traversable LT?	N/A	N/A	Flare Traversable RT?	N/A
N/A	Landing Length (in)	N/A	N/A	DWS Provided?	N/A
N/A	Landing Width (in)	N/A	N/A	DWS Contrast?	N/A
N/A	Landing Slope (%)	N/A	N/A	DWS Length (in)	N/A
N/A	Landing X Slope (%)	N/A	N/A	DWS Full Width?	N/A
N/A	Landing Curb? (Y/N)	N/A	N/A	DWS Offset (in)	N/A
N/A	Shared Landing?	N/A			
N/A	Gutter Ponding?	N/A	N/A	Gutter Slope (%)	N/A
N/A	Gutter Lip Ht (in)	N/A	N/A	Gutter X Slope (%)	N/A
N/A	Painted X Walk1?	No	N/A	Painted X Walk2?	No
	X Walk 1 Direction	To NE		X Walk 2 Direction	To NW
N/A	X Walk 1 Width (in)	N/A	N/A	X Walk 2 Width (in)	N/A
	X Walk 1 Slope (%)	6.1		X Walk 2 Slope (%)	5.5
	X Walk 1 X Slope (%)	2.4		X Walk 2 X Slope (%)	4.2

N/A	Ramp inside XWalk1?	N/A	N/A	Ramp inside XWalk2?	N/A
	Road Slope (%)	2.6	N/A	Clear Space?	N/A
	Road X Slope (%)	7.1	N/A	Clear Space to XWalk (in)	N/A
N/A	Any Obstructions?	N/A	N/A	Storm Grate/Utility Hazard?	N/A
	Obstruction Type			Storm Grate/Utility Type	
		N/A			N/A
			Yes	Surface Condition? (G/P)	Good

Possible Solutions:

Remove & Replace Curb Ramp With Two New Directional Ramps or Equivalent.
