# Access Compliance Report

## Public Rights-of-Way

### (Curb Ramps)

Intersection ID: 8589	Main Street: BRADFORD_DR	Cross Street: WILLARD_ST	Location:	N
ADA ID: 80AF12C0A0EC	Ramp Type: Perp	Initial Pass/Fail: Fail	Overall Compliance: No	Severity Score: 33.75
Codes/Mitigation Info/Possible Solution		Field Measurements/Component Compliance

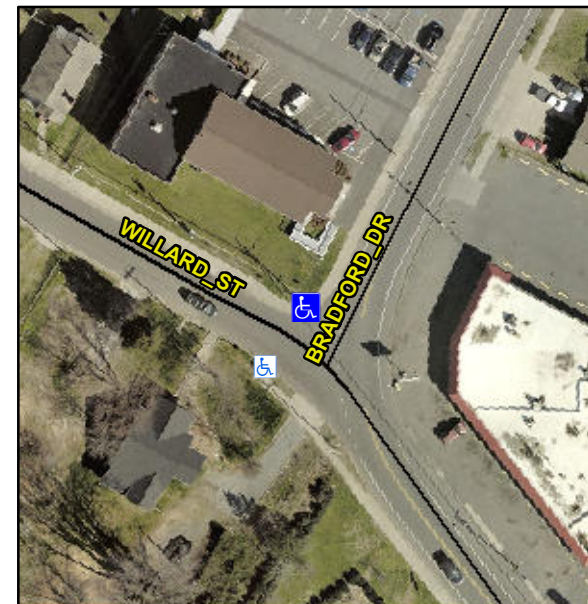
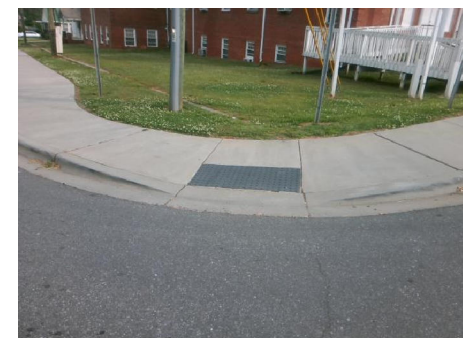
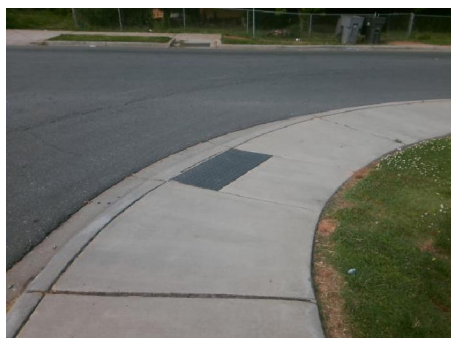
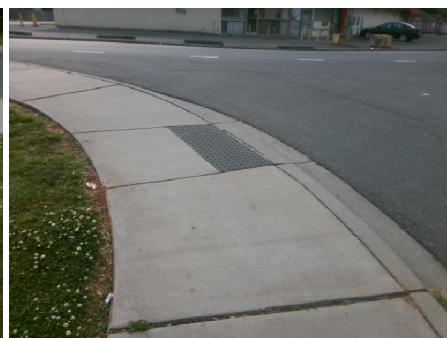
**Not Found, R304.5.1, R304.5.3**

Compliance	Description	Data	Compliance	Description	Data
N/A	Ramp Length (in)	64.0	Yes	Ramp Slope (%)	5.9
No	Ramp Width (in)	44.0	No	Ramp XSlope (%)	8.6
N/A	Flare Type LT	N/A	N/A	Flare Type RT	N/A
N/A	Flare Slope LT (%)	N/A	N/A	Flare Slope RT (%)	N/A
N/A	Flare Traversable LT?	N/A	N/A	Flare Traversable RT?	N/A
N/A	Landing Length (in)	N/A	N/A	DWS Provided?	N/A
N/A	Landing Width (in)	N/A	N/A	DWS Contrast?	N/A
N/A	Landing Slope (%)	N/A	N/A	DWS Length (in)	N/A
N/A	Landing X Slope (%)	N/A	N/A	DWS Full Width?	N/A
N/A	Landing Curb? (Y/N)	N/A	N/A	DWS Offset (in)	N/A
N/A	Shared Landing?	N/A			
N/A	Gutter Ponding?	N/A	N/A	Gutter Slope (%)	N/A
N/A	Gutter Lip Ht (in)	N/A	N/A	Gutter X Slope (%)	N/A
N/A	Painted X Walk1?	No	N/A	Painted X Walk2?	N/A
	X Walk 1 Direction	To S		X Walk 2 Direction	N/A
N/A	X Walk 1 Width (in)	N/A	N/A	X Walk 2 Width (in)	N/A
	X Walk 1 Slope (%)	1.2		X Walk 2 Slope (%)	N/A
	X Walk 1 X Slope (%)	8.8		X Walk 2 X Slope (%)	N/A

N/A	Ramp inside XWalk1?	N/A	N/A	Ramp inside XWalk2?	N/A
	Road Slope (%)	N/A	N/A	Clear Space?	N/A
	Road X Slope (%)	N/A	N/A	Clear Space to XWalk (in)	N/A
N/A	Any Obstructions?	N/A	N/A	Storm Grate/Utility Hazard?	N/A
	Obstruction Type			Storm Grate/Utility Type	
		N/A			N/A
			Yes	Surface Condition? (G/P)	Good

**Remove & Replace Entire Ramp.**

Total Cost: \$ 1850.00
