Access Compliance Report

Public Rights-of-Way

(Curb Ramps)

Intersection ID: 9209	Main Street: ARDEN_ST	Cross Street: EDISON_ST	Location: NW
ADA ID: 80AF7C0FD0CE	Ramp Type: Para	Initial Pass/Fail: Fail	Overall Compliance: No
		Severity Score: 22.5

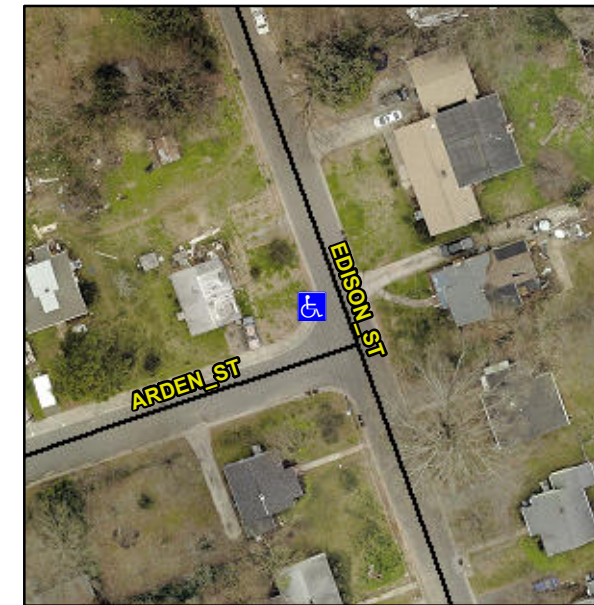
RT RP < 5%, NO RT SW

Compliance	Description	Data	Compliance	Description	Data
N/A	Ramp Length LT (in)	52.0	N/A	Ramp Length RT (in)	60.0
Yes	Ramp Width LT (in)	60.0	No	Ramp Width RT (in)	39.0
No	Ramp Slope LT (%)	8.5	Yes	Ramp Slope RT (%)	4.9
No	Ramp XSlope LT (%)	4.4	No	Ramp XSlope RT (%)	2.6
N/A	Landing Length (in)	N/A	N/A	DWS Provided?	N/A
N/A	Landing Width (in)	N/A	N/A	DWS Contrast?	N/A
N/A	Landing Slope (%)	N/A	N/A	DWS Length (in)	N/A
N/A	Landing X Slope (%)	N/A	N/A	DWS Full Width?	N/A
N/A	Landing Curb? (Y/N)	N/A	N/A	DWS Offset (in)	N/A
N/A	Shared Landing?	N/A			
N/A	Gutter Ponding?	N/A	N/A	Gutter Slope (%)	N/A
N/A	Gutter Lip Ht (in)	N/A	N/A	Gutter X Slope (%)	N/A
N/A	Painted X Walk1?	No	N/A	Painted X Walk2?	N/A
	X Walk 1 Direction	To E		X Walk 2 Direction	N/A
N/A	X Walk 1 Width (in)	N/A	N/A	X Walk 2 Width (in)	N/A
	X Walk 1 Slope (%)	2.7		X Walk 2 Slope (%)	N/A
	X Walk 1 X Slope (%)	1.9		X Walk 2 X Slope (%)	N/A
N/A	Ramp inside XWalk1?	N/A	N/A	Ramp inside XWalk2?	N/A

Road Slope (%)	N/A	N/A	Clear Space?	N/A
	Road X Slope (%)	N/A	N/A	Clear Space to XWalk (in)	N/A
N/A	Any Obstructions?	N/A	N/A	Storm Grate/Utility Hazard?	N/A
	Obstruction Type			Storm Grate/Utility Type	
		N/A			N/A
			Yes	Surface Condition? (G/P)	Good
			N/A	Curb Slope (%)	24.9

Remove & Replace Entire Ramp.
