Access Compliance Report

Public Rights-of-Way

(Curb Ramps)

| Intersection ID: 10023486 | Main Street: CIRCUMFERENTIAL_RD | Cross Street: N/A | Location: | NE |

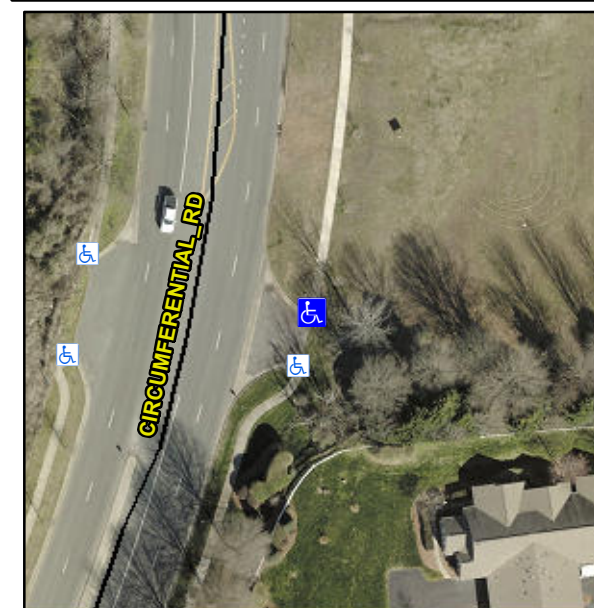
| ADA ID: 80B0D6ACFBE0 | Ramp Type: BlendTrans1 | Initial Pass/Fail: Pass | Overall Compliance: No | Severity Score: 2.5 |

| Compliance | Description | Data | Compliance | Description | Data |
|---|---|---|---|---|---|
| No | Landing Slope (%) | 3.7 | Yes | DWS Length (in) | 24.0 |
| No | Landing X Slope (%) | 2.8 | No | DWS Full Width? | No |
| Yes | Gutter Lip Ht (in) | 0.0 | No | Gutter X Slope (%) | 4.1 |

Remove & Replace Curb Ramp With Two New Directional Ramps or Equivalent. Remove & Replace Gutter.

R304.2.2-Perp, R304.3.2-Para, R304.5.3, R305.1.4
