Access Compliance Report

(Curb Ramps)

Intersection ID: 17334	Main Street: LYNNWOOD_DR	Cross Street: STERLING_RD	Location: SW
ADA ID: 80BA9108E4A3	Ramp Type: PerpDiag	Initial Pass/Fail: Fail	Overall Compliance: No
		Severity Score: 12.5

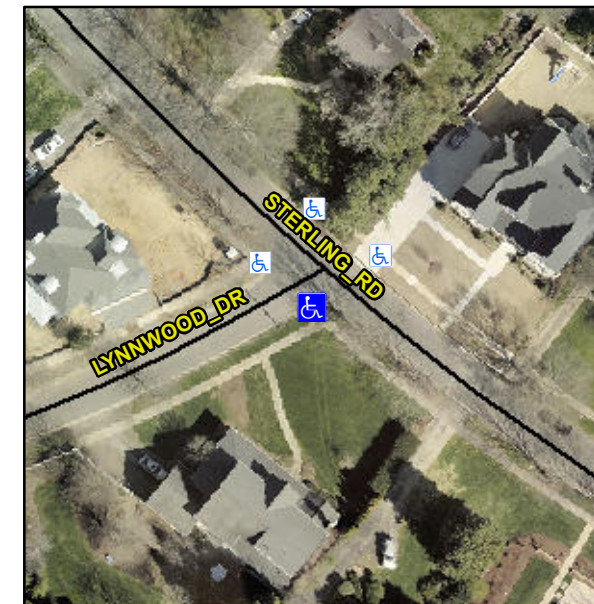
Compliance	Description	Data	Compliance	Description	Data
N/A	Ramp Length (in)	43.0	No	Ramp Slope (%)	10.1
Yes	Ramp Width (in)	48.0	Yes	Ramp XSlope (%)	1.1
N/A	Flare Type LT	N/A	N/A	Flare Type RT	N/A
N/A	Flare Slope LT (%)	N/A	N/A	Flare Slope RT (%)	N/A
N/A	Flare Traversable LT?	N/A	N/A	Flare Traversable RT?	N/A
N/A	Landing Length (in)	N/A	N/A	DWS Provided?	N/A
N/A	Landing Width (in)	N/A	N/A	DWS Contrast?	N/A
N/A	Landing Slope (%)	N/A	N/A	DWS Length (in)	N/A
N/A	Landing X Slope (%)	N/A	N/A	DWS Full Width?	N/A
N/A	Landing Curb? (Y/N)	N/A	N/A	DWS Offset (in)	N/A
N/A	Shared Landing?	N/A			
N/A	Gutter Ponding?	N/A	N/A	Gutter Slope (%)	N/A
N/A	Gutter Lip Ht (in)	N/A	N/A	Gutter X Slope (%)	N/A
N/A	Painted X Walk1?	No	N/A	Painted X Walk2?	No
	X Walk 1 Direction	To NE		X Walk 2 Direction	To NW
N/A	X Walk 1 Width (in)	N/A	N/A	X Walk 2 Width (in)	N/A
	X Walk 1 Slope (%)	4.8		X Walk 2 Slope (%)	2.1
	X Walk 1 X Slope (%)	4.1		X Walk 2 X Slope (%)	2.0

N/A	Ramp inside XWalk1?	N/A	N/A	Ramp inside XWalk2?	N/A
	Road Slope (%)	1.3	N/A	Clear Space?	N/A
	Road X Slope (%)	4.4	N/A	Clear Space to XWalk (in)	N/A
N/A	Any Obstructions?	N/A	N/A	Storm Grate/Utility Hazard?	N/A
	Obstruction Type			Storm Grate/Utility Type	
		N/A			N/A
			Yes	Surface Condition? (G/P)	Good

Remove & Replace Curb Ramp With Two New Directional Ramps or Equivalent.

R304.2.2
