Access Compliance Report

Public Rights-of-Way

(Curb Ramps)

Intersection ID: 54460	Main Street: STEELE_MEADOW_RD	Cross Street: FLINT_HILL_DR	Location: NE
ADA ID: 80C834204B77	Ramp Type: Perp	Initial Pass/Fail: Fail	Overall Compliance: No
Severity Score: 21.25			
Codes/Mitigation Info/Possible Solution		Field Measurements/Component Compliance

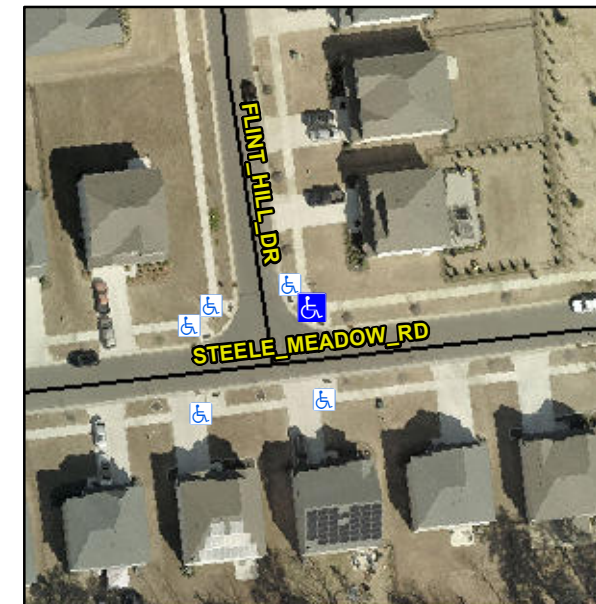
Compliance	Description	Data	Compliance	Description	Data
N/A	Ramp Length (in)	97.0	No	Ramp Slope (%)	9.3
No	Ramp Width (in)	46.0	Yes	Ramp XSlope (%)	1.2
N/A	Flare Type LT	N/A	N/A	Flare Type RT	N/A
N/A	Flare Slope LT (%)	N/A	N/A	Flare Slope RT (%)	N/A
N/A	Flare Traversable LT?	N/A	N/A	Flare Traversable RT?	N/A
N/A	Landing Length (in)	N/A	N/A	DWS Provided?	N/A
N/A	Landing Width (in)	N/A	N/A	DWS Contrast?	N/A
N/A	Landing Slope (%)	N/A	N/A	DWS Length (in)	N/A
N/A	Landing X Slope (%)	N/A	N/A	DWS Full Width?	N/A
N/A	Landing Curb? (Y/N)	N/A	N/A	DWS Offset (in)	N/A
N/A	Shared Landing?	N/A			
N/A	Gutter Ponding?	N/A	N/A	Gutter Slope (%)	N/A
N/A	Gutter Lip Ht (in)	1.0	N/A	Gutter X Slope (%)	N/A
N/A	Painted X Walk1?	No	N/A	Painted X Walk2?	N/A
	X Walk 1 Direction	To S		X Walk 2 Direction	N/A
N/A	X Walk 1 Width (in)	N/A	N/A	X Walk 2 Width (in)	N/A
	X Walk 1 Slope (%)	1.5		X Walk 2 Slope (%)	N/A
	X Walk 1 X Slope (%)	2.1		X Walk 2 X Slope (%)	N/A

Possible Solutions:

Remove & Replace Entire Ramp.

R304.5.1, R304.2.2

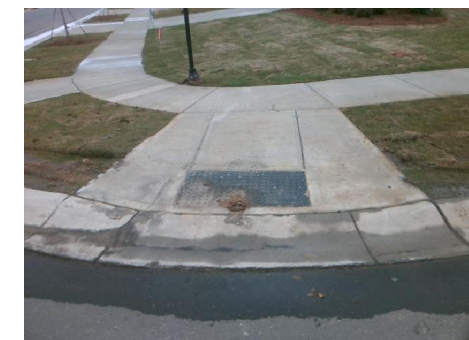
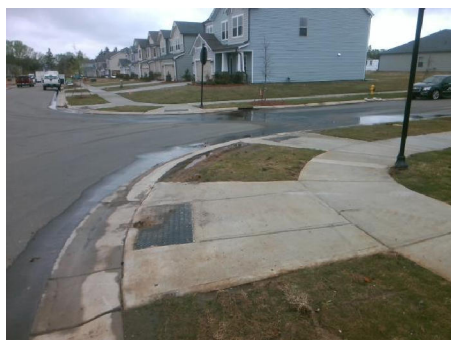
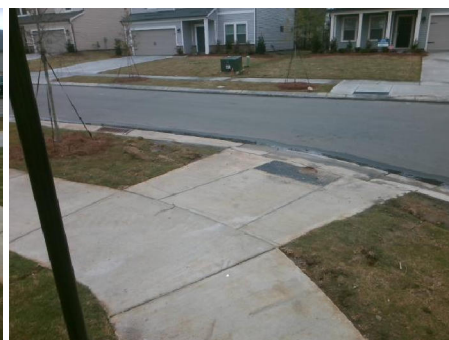
N/A	Ramp inside XWalk1?	N/A	N/A	Ramp inside XWalk2?	N/A
	Road Slope (%)	N/A	N/A	Clear Space?	N/A
	Road X Slope (%)	N/A	N/A	Clear Space to XWalk (in)	N/A
N/A	Any Obstructions?	N/A	N/A	Storm Grate/Utility Hazard?	N/A
	Obstruction Type			Storm Grate/Utility Type	
		N/A			N/A
			Yes	Surface Condition? (G/P)	Good
