Access Compliance Report

Public Rights-of-Way

(Curb Ramps)

Intersection ID: 3495	Main Street: MAPLE_VIEW_LN	Cross Street: W_W_T_HARRIS_BV	Location: SW
ADA ID: 80C92FEA2972	Ramp Type: Perp	Initial Pass/Fail: Fail	Overall Compliance: No
Severity Score: 22.5			
Codes/Mitigation Info/Possible Solution		Field Measurements/Component Compliance

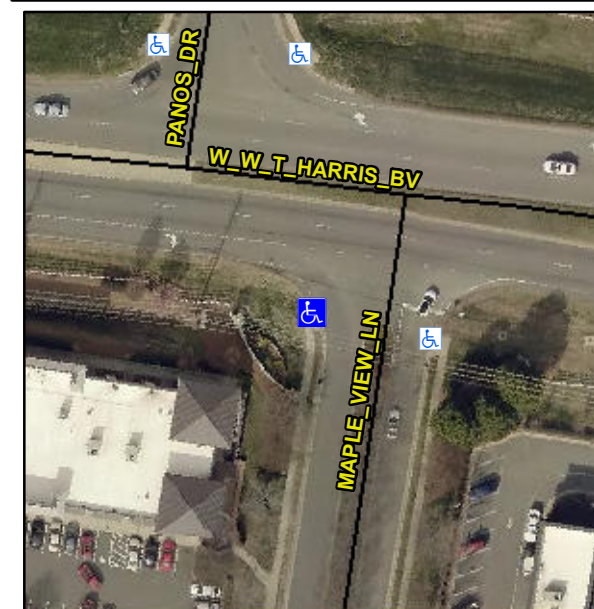
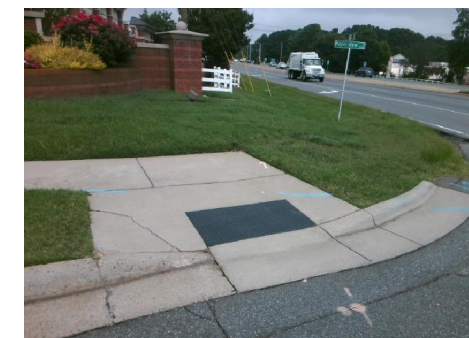
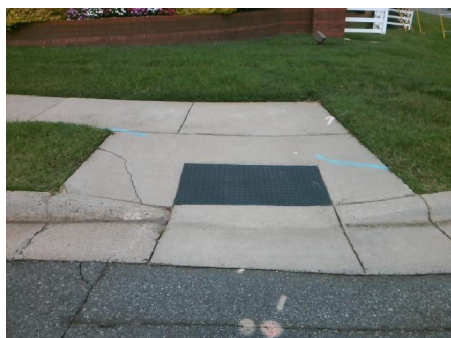
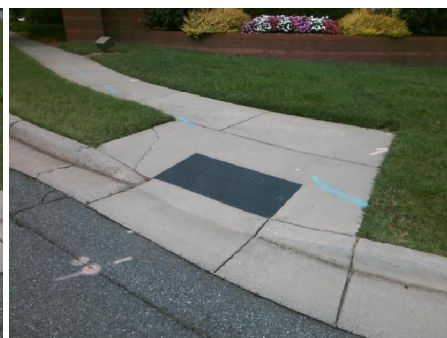
Not Found, R304.5.1, R304.2.2, R304.5.3

Compliance	Description	Data	Compliance	Description	Data
N/A	Ramp Length (in)	51.0	No	Ramp Slope (%)	10.2
No	Ramp Width (in)	47.0	No	Ramp XSlope (%)	4.4
N/A	Flare Type LT	N/A	N/A	Flare Type RT	N/A
N/A	Flare Slope LT (%)	N/A	N/A	Flare Slope RT (%)	N/A
N/A	Flare Traversable LT?	N/A	N/A	Flare Traversable RT?	N/A
N/A	Landing Length (in)	N/A	N/A	DWS Provided?	N/A
N/A	Landing Width (in)	N/A	N/A	DWS Contrast?	N/A
N/A	Landing Slope (%)	N/A	N/A	DWS Length (in)	N/A
N/A	Landing X Slope (%)	N/A	N/A	DWS Full Width?	N/A
N/A	Landing Curb? (Y/N)	N/A	N/A	DWS Offset (in)	N/A
N/A	Shared Landing?	N/A			
N/A	Gutter Ponding?	N/A	N/A	Gutter Slope (%)	N/A
N/A	Gutter Lip Ht (in)	N/A	N/A	Gutter X Slope (%)	N/A
N/A	Painted X Walk1?	No	N/A	Painted X Walk2?	N/A
	X Walk 1 Direction	To E		X Walk 2 Direction	N/A
N/A	X Walk 1 Width (in)	N/A	N/A	X Walk 2 Width (in)	N/A
	X Walk 1 Slope (%)	5.6		X Walk 2 Slope (%)	N/A
	X Walk 1 X Slope (%)	4.8		X Walk 2 X Slope (%)	N/A

N/A	Ramp inside XWalk1?	N/A	N/A	Ramp inside XWalk2?	N/A
	Road Slope (%)	N/A	N/A	Clear Space?	N/A
	Road X Slope (%)	N/A	N/A	Clear Space to XWalk (in)	N/A
N/A	Any Obstructions?	N/A	N/A	Storm Grate/Utility Hazard?	N/A
	Obstruction Type			Storm Grate/Utility Type	
		N/A			N/A
			Yes	Surface Condition? (G/P)	Good

Possible Solutions:

Remove & Replace Entire Ramp.
