# Access Compliance Report

## Public Rights-of-Way

### (Curb Ramps)

Intersection ID: 31526	Main Street: WILGROVE WAY DR	Cross Street: CARLEEN WAY DR	Location: E
ADA ID: 80CA18B41524	Ramp Type: BlendTrans1	Initial Pass/Fail: Fail	Overall Compliance: No
			Severity Score: 21.25

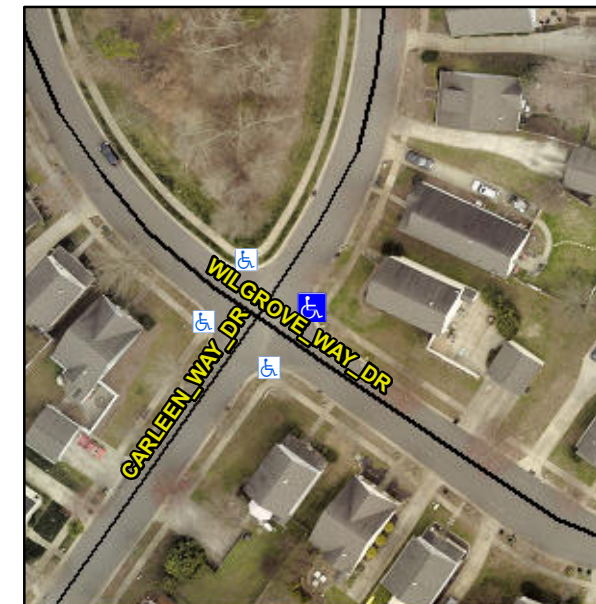
Compliance	Description	Data	Compliance	Description	Data
N/A	Ramp Length (in)	48.0	Yes	BlendTrans Slope (%)	3.5
No	Ramp Width (in)	42.0	No	BlendTrans XSlope (%)	6.5
N/A	Flare Type LT	N/A	N/A	Flare Type RT	N/A
N/A	Flare Slope LT (%)	N/A	N/A	Flare Slope RT (%)	N/A
N/A	Flare Traversable LT?	N/A	N/A	Flare Traversable RT?	N/A
N/A	Landing Length (in)	N/A	N/A	DWS Provided?	N/A
N/A	Landing Width (in)	N/A	N/A	DWS Contrast?	N/A
N/A	Landing Slope (%)	N/A	N/A	DWS Length (in)	N/A
N/A	Landing X Slope (%)	N/A	N/A	DWS Full Width?	N/A
N/A	Landing Curb? (Y/N)	N/A	N/A	DWS Offset (in)	N/A
N/A	Shared Landing?	N/A			
N/A	Gutter Ponding?	N/A	N/A	Gutter Slope (%)	N/A
N/A	Gutter Lip Ht (in)	N/A	N/A	Gutter X Slope (%)	N/A
N/A	Painted X Walk1?	No	N/A	Painted X Walk2?	No
	X Walk 1 Direction	To NW		X Walk 2 Direction	To SW
	X Walk 1 Width (in)	N/A		X Walk 2 Width (in)	N/A
	X Walk 1 Slope (%)	1.3		X Walk 2 Slope (%)	5.5
	X Walk 1 X Slope (%)	4.4		X Walk 2 X Slope (%)	3.5

N/A	Ramp inside XWalk1?	N/A	N/A	Ramp inside XWalk2?	N/A
	Road Slope (%)	6.4		Clear Space?	N/A
	Road X Slope (%)	1.0	N/A	Clear Space to XWalk (in)	N/A
N/A	Any Obstructions?	N/A	N/A	Storm Grate/Utility Hazard?	N/A
	Obstruction Type			Storm Grate/Utility Type	
		N/A			N/A
			Yes	Surface Condition? (G/P)	Good
			N/A	Curb Slope (%)	N/A

Possible Solutions:

**Remove & Replace Curb Ramp With Two New Directional Ramps or Equivalent.**

**R304.5.1, R304.5.3**

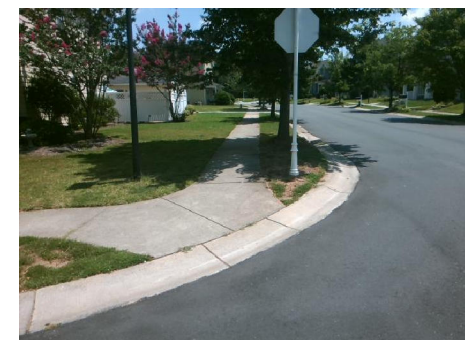
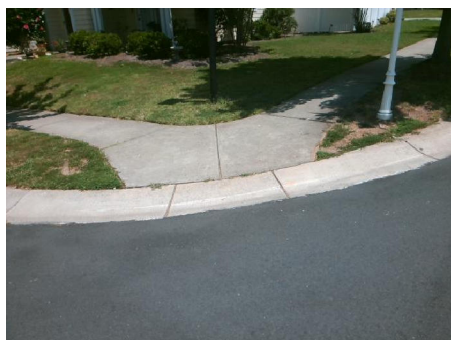
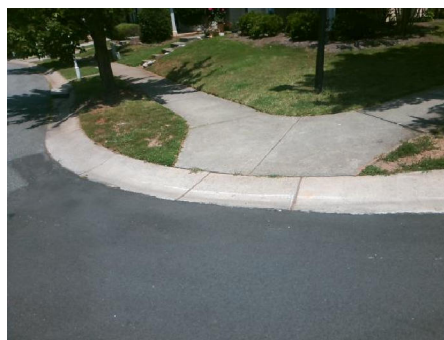
Street 1 Name **CARLEEN WAY DR**  
 Stop Condition-Street 1 **None**  
 Street 2 Name **WILGROVE WAY DR**  
 Stop Condition-Street 2 **StopSign**
