Access Compliance Report

Public Rights-of-Way

(Curb Ramps)

Intersection ID: 2591	Main Street: BEARDSLEY_DR	Cross Street: HARTFIELD_DOWNS_DR	Location: SW
ADA ID: 80D5A0043A88	Ramp Type: PerpDiag	Initial Pass/Fail: Fail	Overall Compliance: No
		Severity Score: 25

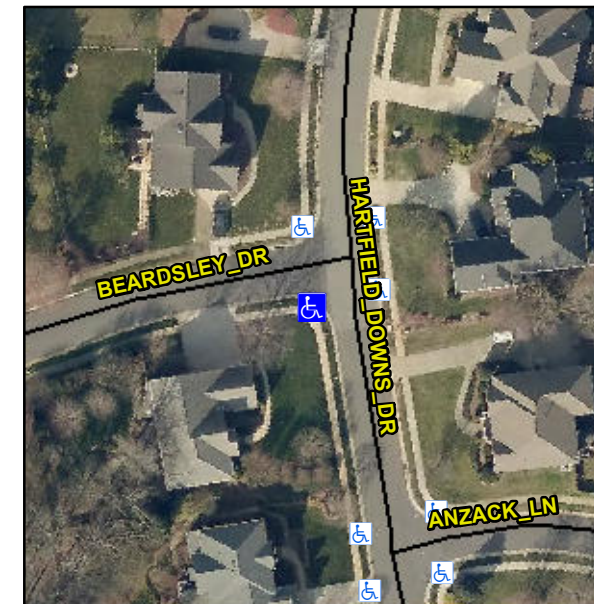
Not Found, R304.5.3

Compliance	Description	Data	Compliance	Description	Data
N/A	Ramp Length (in)	47.0	Yes	Ramp Slope (%)	5.4
Yes	Ramp Width (in)	48.0	No	Ramp XSlope (%)	9.0
N/A	Flare Type LT	N/A	N/A	Flare Type RT	N/A
N/A	Flare Slope LT (%)	N/A	N/A	Flare Slope RT (%)	N/A
N/A	Flare Traversable LT?	N/A	N/A	Flare Traversable RT?	N/A
N/A	Landing Length (in)	N/A	N/A	DWS Provided?	N/A
N/A	Landing Width (in)	N/A	N/A	DWS Contrast?	N/A
N/A	Landing Slope (%)	N/A	N/A	DWS Length (in)	N/A
N/A	Landing X Slope (%)	N/A	N/A	DWS Full Width?	N/A
N/A	Landing Curb? (Y/N)	N/A	N/A	DWS Offset (in)	N/A
N/A	Shared Landing?	N/A			
N/A	Gutter Ponding?	N/A	N/A	Gutter Slope (%)	N/A
N/A	Gutter Lip Ht (in)	N/A	N/A	Gutter X Slope (%)	N/A
N/A	Painted X Walk1?	No	N/A	Painted X Walk2?	No
	X Walk 1 Direction	To E		X Walk 2 Direction	To N
N/A	X Walk 1 Width (in)	N/A	N/A	X Walk 2 Width (in)	N/A
	X Walk 1 Slope (%)	2.6		X Walk 2 Slope (%)	4.9
	X Walk 1 X Slope (%)	6.0		X Walk 2 X Slope (%)	2.5

N/A	Ramp inside XWalk1?	N/A	N/A	Ramp inside XWalk2?	N/A
	Road Slope (%)	5.2	N/A	Clear Space?	N/A
	Road X Slope (%)	2.4	N/A	Clear Space to XWalk (in)	N/A
N/A	Any Obstructions?	N/A	N/A	Storm Grate/Utility Hazard?	N/A
	Obstruction Type			Storm Grate/Utility Type	
		N/A			N/A
		Yes		Surface Condition? (G/P)	Good

Remove & Replace Curb Ramp With Two New Directional Ramps or Equivalent.
