Access Compliance Report

Public Rights-of-Way

(Curb Ramps)

Intersection ID: N/A	Main Street: MORABLIN_DR	Cross Street: DURANT_BV	Location: SE
ADA ID: 80D9008B80FA	Ramp Type: PerpDiag	Initial Pass/Fail: Fail	Overall Compliance: No
Codes/Mitigation Info/Possible Solution		Field Measurements/Component Compliance

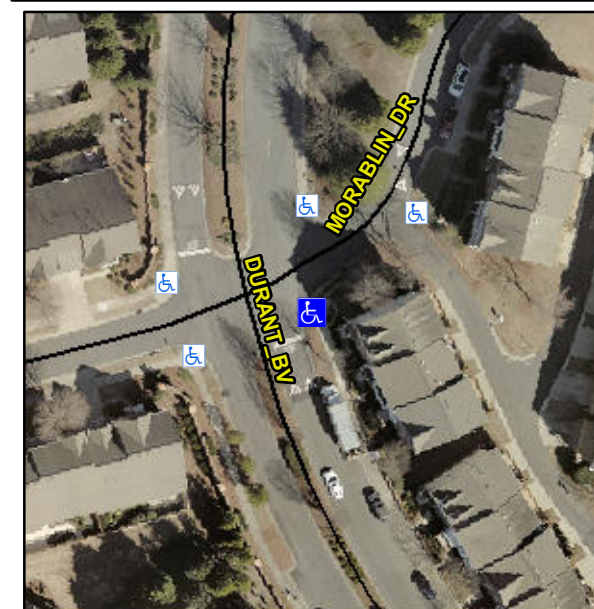
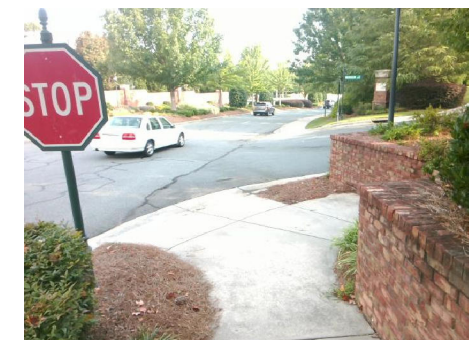
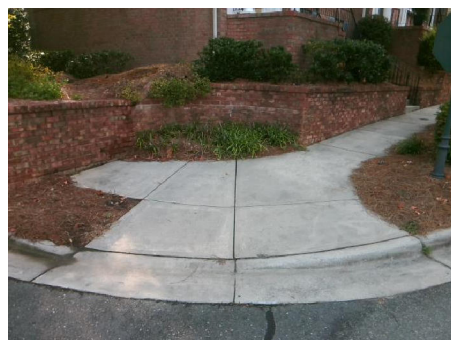
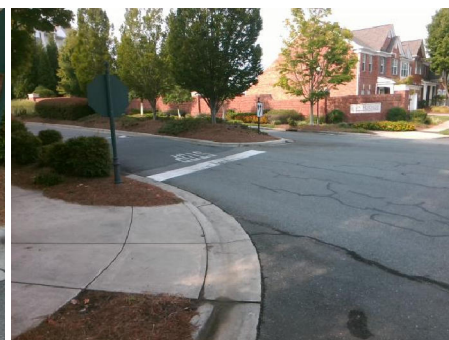
Not Found, R304.5.1, R304.2.2, R304.5.3

Compliance	Description	Data	Compliance	Description	Data
N/A	Ramp Length (in)	120.0	No	Ramp Slope (%)	8.9
No	Ramp Width (in)	32.0	No	Ramp XSlope (%)	2.8
N/A	Flare Type LT	N/A	N/A	Flare Type RT	N/A
N/A	Flare Slope LT (%)	N/A	N/A	Flare Slope RT (%)	N/A
N/A	Flare Traversable LT?	N/A	N/A	Flare Traversable RT?	N/A
N/A	Landing Length (in)	N/A	N/A	DWS Provided?	N/A
N/A	Landing Width (in)	N/A	N/A	DWS Contrast?	N/A
N/A	Landing Slope (%)	N/A	N/A	DWS Length (in)	N/A
N/A	Landing X Slope (%)	N/A	N/A	DWS Full Width?	N/A
N/A	Landing Curb? (Y/N)	N/A	N/A	DWS Offset (in)	N/A
N/A	Shared Landing?	N/A			
N/A	Gutter Ponding?	N/A	N/A	Gutter Slope (%)	N/A
N/A	Gutter Lip Ht (in)	N/A	N/A	Gutter X Slope (%)	N/A
N/A	Painted X Walk1?	No	N/A	Painted X Walk2?	No
	X Walk 1 Direction	To N		X Walk 2 Direction	To W
N/A	X Walk 1 Width (in)	N/A	N/A	X Walk 2 Width (in)	N/A
	X Walk 1 Slope (%)	4.7		X Walk 2 Slope (%)	1.6
	X Walk 1 X Slope (%)	3.3		X Walk 2 X Slope (%)	4.7

N/A	Ramp inside XWalk1?	N/A	N/A	Ramp inside XWalk2?	N/A
	Road Slope (%)	0.1	N/A	Clear Space?	N/A
	Road X Slope (%)	7.6	N/A	Clear Space to XWalk (in)	N/A
N/A	Any Obstructions?	N/A	N/A	Storm Grate/Utility Hazard?	N/A
	Obstruction Type			Storm Grate/Utility Type	
		N/A			N/A
		Yes		Surface Condition? (G/P)	Good

Remove & Replace Curb Ramp With Two New Directional Ramps or Equivalent.
