# Access Compliance Report

## Public Rights-of-Way

### (Curb Ramps)

Intersection ID: 17854	Main Street: HARDWICK_RD	Cross Street: N_SHARON_AMITY_RD	Location: SE
ADA ID: 80E272BB6438	Ramp Type: ParaDiag	Initial Pass/Fail: Fail	Overall Compliance: No
Codes/Mitigation Info/Possible Solution		Field Measurements/Component Compliance	
Severity Score: 13.75

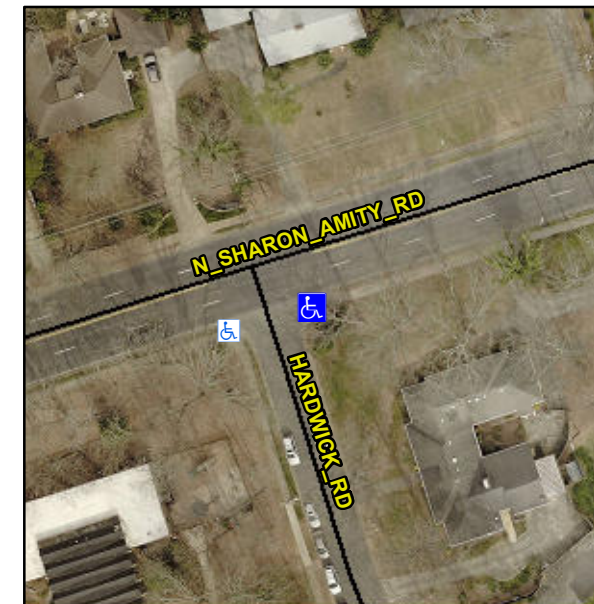
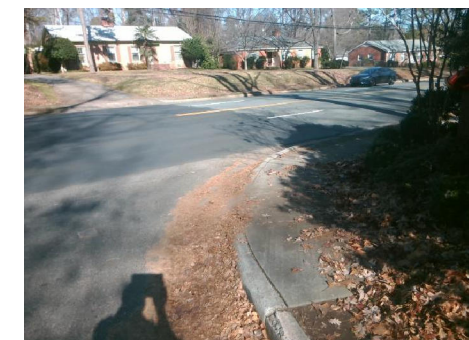
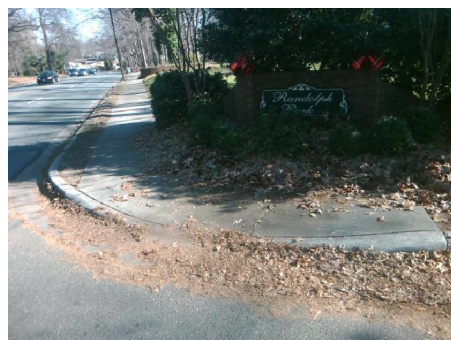
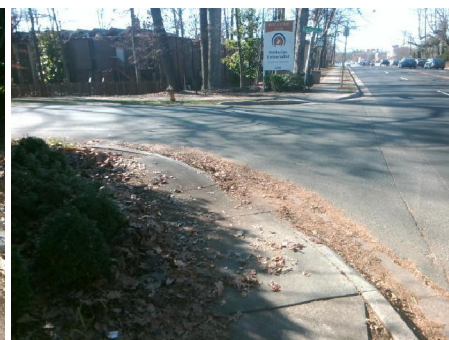
**LT RP < 5%**

Compliance	Description	Data	Compliance	Description	Data
N/A	Ramp Length LT (in)	37.0	N/A	Ramp Length RT (in)	66.0
Yes	Ramp Width LT (in)	48.0	Yes	Ramp Width RT (in)	48.0
Yes	Ramp Slope LT (%)	3.8	No	Ramp Slope RT (%)	11.4
No	Ramp XSlope LT (%)	4.3	No	Ramp XSlope RT (%)	2.7
N/A	Landing Length (in)	N/A	N/A	DWS Provided?	N/A
N/A	Landing Width (in)	N/A	N/A	DWS Contrast?	N/A
N/A	Landing Slope (%)	N/A	N/A	DWS Length (in)	N/A
N/A	Landing X Slope (%)	N/A	N/A	DWS Full Width?	N/A
N/A	Landing Curb? (Y/N)	N/A	N/A	DWS Offset (in)	N/A
N/A	Shared Landing?	N/A			
N/A	Gutter Ponding?	N/A	N/A	Gutter Slope (%)	N/A
N/A	Gutter Lip Ht (in)	N/A	N/A	Gutter X Slope (%)	N/A
N/A	Painted X Walk1?	No	N/A	Painted X Walk2?	No
	X Walk 1 Direction	To NW		X Walk 2 Direction	To SW
N/A	X Walk 1 Width (in)	N/A	N/A	X Walk 2 Width (in)	N/A
	X Walk 1 Slope (%)	3.1		X Walk 2 Slope (%)	0.2
	X Walk 1 X Slope (%)	1.6		X Walk 2 X Slope (%)	3.5
N/A	Ramp inside XWalk1?	N/A	N/A	Ramp inside XWalk2?	N/A

Road Slope (%)	5.5	N/A	Clear Space?	N/A
	Road X Slope (%)	2.0	N/A	Clear Space to XWalk (in)	N/A
N/A	Any Obstructions?	N/A	N/A	Storm Grate/Utility Hazard?	N/A
	Obstruction Type			Storm Grate/Utility Type	
		N/A			N/A
			Yes	Surface Condition? (G/P)	Good
			N/A	Curb Slope (%)	7.2

**Remove & Replace Curb Ramp With Two New Directional Ramps or Equivalent.**

**R304.5.3, R304.3.2**
