# Access Compliance Report

## Public Rights-of-Way

### (Curb Ramps)

Intersection ID: 23437	Main Street: TRYON_ST	Cross Street: MOSS_LN	Location:	E
ADA ID: 80EB002D919D	Ramp Type: MedianPerp	Initial Pass/Fail: Pass	Overall Compliance: No	Severity Score: 5.25
Codes/Mitigation Info/Possible Solution		Field Measurements/Component Compliance

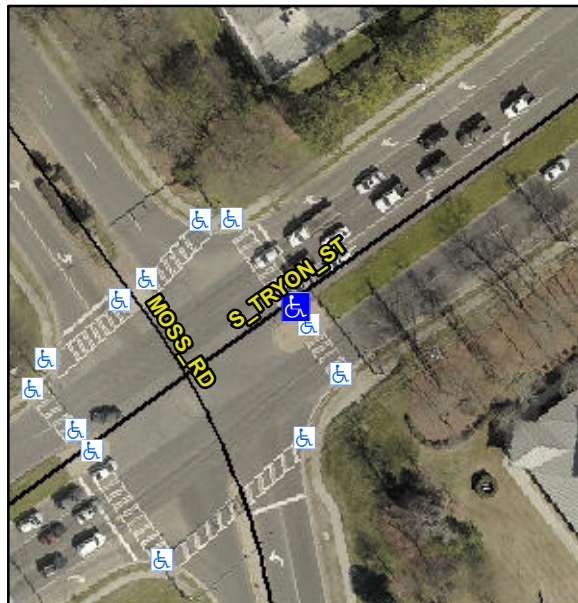
**Not Found, R304.5.3, R304.2.1,  
R302.7, R304.5.4**

Compliance	Description	Data	Compliance	Description	Data
N/A	Ramp Length (in)	64.0	Yes	Ramp Slope (%)	5.4
Yes	Ramp Width (in)	48.0	No	Ramp XSlope (%)	2.2
N/A	Flare Type LT	Sloped	N/A	Flare Type RT	N/A
N/A	Flare Slope LT (%)	4.3	Yes	Flare Slope RT (%)	3.7
N/A	Flare Traversable LT?	Yes	N/A	Flare Traversable RT?	Yes
No	Landing Length (in)	36.0	Yes	DWS Provided?	Yes
Yes	Landing Width (in)	48.0	Yes	DWS Contrast?	Yes
Yes	Landing Slope (%)	0.6	Yes	DWS Length (in)	25.5
Yes	Landing X Slope (%)	0.9	Yes	DWS Full Width?	Yes
N/A	Landing Curb? (Y/N)	N/A	Yes	DWS Offset (in)	0.0
N/A	Shared Landing?	Yes			
No	Gutter Ponding?	Yes	No	Gutter Slope (%)	6.9
Yes	Gutter Lip Ht (in)	0.0	Yes	Gutter X Slope (%)	1.2
N/A	Painted X Walk1?	Yes	N/A	Painted X Walk2?	N/A
	X Walk 1 Direction	To N		X Walk 2 Direction	N/A
N/A	X Walk 1 Width (in)	119.0	N/A	X Walk 2 Width (in)	N/A
	X Walk 1 Slope (%)	2.4		X Walk 2 Slope (%)	N/A
	X Walk 1 X Slope (%)	1.0		X Walk 2 X Slope (%)	N/A

Yes	Ramp inside XWalk1?	Yes	N/A	Ramp inside XWalk2?	N/A
	Road Slope (%)	N/A	N/A	Clear Space?	Yes
	Road X Slope (%)	N/A	N/A	Clear Space to XWalk (in)	N/A
Yes	Any Obstructions?	No	Yes	Storm Grate/Utility Hazard?	No
	Obstruction Type			Storm Grate/Utility Type	
			N/A		N/A
			Yes	Surface Condition? (G/P)	Good

**Remove & Replace Entire Ramp.  
Remove & Replace Gutter.**
