# Access Compliance Report

## Public Rights-of-Way

### (Curb Ramps)

Intersection ID: 3714	Main Street: HARRIS_OAKS_BV	Cross Street: STATESVILLE_RD	Location: W
ADA ID: 80F8295A466A	Ramp Type: Perp	Initial Pass/Fail: Fail	Overall Compliance: No
Severity Score: 22.5			
Codes/Mitigation Info/Possible Solution		Field Measurements/Component Compliance

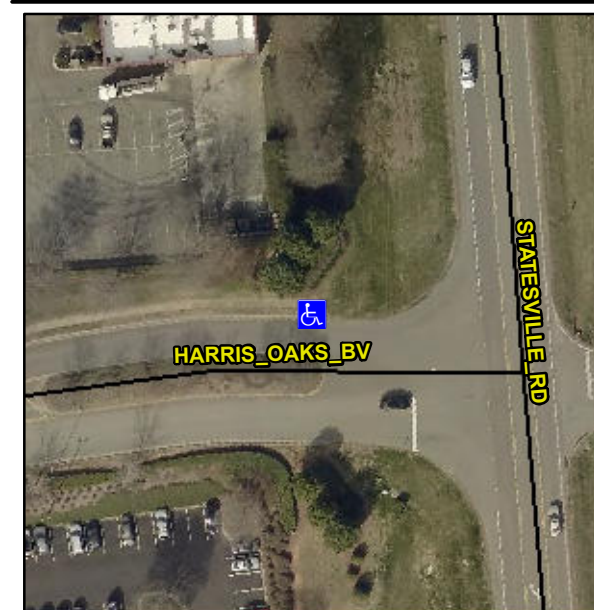
**Not Found, R304.5.1, R304.2.2, R304.5.3**

Compliance	Description	Data	Compliance	Description	Data
N/A	Ramp Length (in)	48.0	No	Ramp Slope (%)	11.9
No	Ramp Width (in)	45.0	No	Ramp XSlope (%)	3.0
N/A	Flare Type LT	N/A	N/A	Flare Type RT	N/A
N/A	Flare Slope LT (%)	N/A	N/A	Flare Slope RT (%)	N/A
N/A	Flare Traversable LT?	N/A	N/A	Flare Traversable RT?	N/A
N/A	Landing Length (in)	N/A	N/A	DWS Provided?	N/A
N/A	Landing Width (in)	N/A	N/A	DWS Contrast?	N/A
N/A	Landing Slope (%)	N/A	N/A	DWS Length (in)	N/A
N/A	Landing X Slope (%)	N/A	N/A	DWS Full Width?	N/A
N/A	Landing Curb? (Y/N)	N/A	N/A	DWS Offset (in)	N/A
N/A	Shared Landing?	N/A			
N/A	Gutter Ponding?	N/A	N/A	Gutter Slope (%)	N/A
N/A	Gutter Lip Ht (in)	N/A	N/A	Gutter X Slope (%)	N/A
N/A	Painted X Walk1?	No	N/A	Painted X Walk2?	N/A
	X Walk 1 Direction	To E		X Walk 2 Direction	N/A
N/A	X Walk 1 Width (in)	N/A	N/A	X Walk 2 Width (in)	N/A
	X Walk 1 Slope (%)	2.0		X Walk 2 Slope (%)	N/A
	X Walk 1 X Slope (%)	3.8		X Walk 2 X Slope (%)	N/A

N/A	Ramp inside XWalk1?	N/A	N/A	Ramp inside XWalk2?	N/A
	Road Slope (%)	N/A	N/A	Clear Space?	N/A
	Road X Slope (%)	N/A	N/A	Clear Space to XWalk (in)	N/A
N/A	Any Obstructions?	N/A	N/A	Storm Grate/Utility Hazard?	N/A
	Obstruction Type			Storm Grate/Utility Type	
		N/A			N/A
			Yes	Surface Condition? (G/P)	Good

**Remove & Replace Entire Ramp.**

Total Cost: \$ 1850.00
