Access Compliance Report

Public Rights-of-Way

(Curb Ramps)

Intersection ID: 29706	Main Street: SIMFIELD_CHURCH_RD	Cross Street: WEDDINGTON_RIDGE_LN	Location:	N
ADA ID: 80FA3F4E0EA8	Ramp Type: Perp	Initial Pass/Fail: Fail	Overall Compliance: No	Severity Score: 17.5
Codes/Mitigation Info/Possible Solution		Field Measurements/Component Compliance

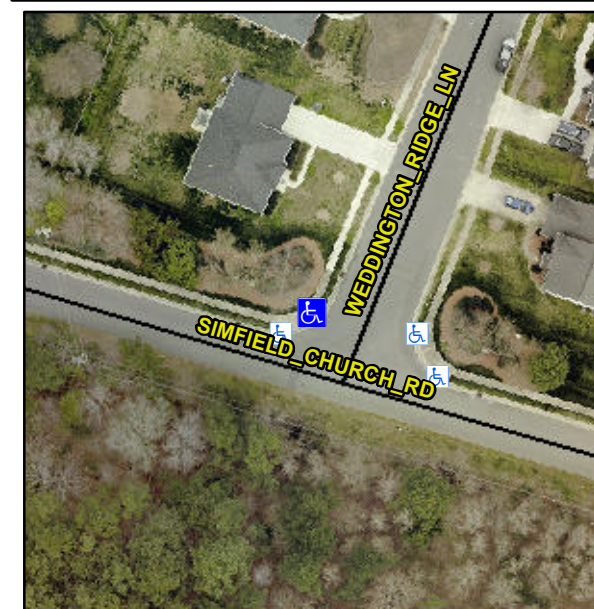
Not Found, R304.5.1

Compliance	Description	Data	Compliance	Description	Data
N/A	Ramp Length (in)	51.5	Yes	Ramp Slope (%)	6.0
No	Ramp Width (in)	35.0	Yes	Ramp XSlope (%)	0.0
N/A	Flare Type LT	N/A	N/A	Flare Type RT	N/A
N/A	Flare Slope LT (%)	N/A	N/A	Flare Slope RT (%)	N/A
N/A	Flare Traversable LT?	N/A	N/A	Flare Traversable RT?	N/A
N/A	Landing Length (in)	N/A	N/A	DWS Provided?	N/A
N/A	Landing Width (in)	N/A	N/A	DWS Contrast?	N/A
N/A	Landing Slope (%)	N/A	N/A	DWS Length (in)	N/A
N/A	Landing X Slope (%)	N/A	N/A	DWS Full Width?	N/A
N/A	Landing Curb? (Y/N)	N/A	N/A	DWS Offset (in)	N/A
N/A	Shared Landing?	N/A			
N/A	Gutter Ponding?	N/A	N/A	Gutter Slope (%)	N/A
N/A	Gutter Lip Ht (in)	N/A	N/A	Gutter X Slope (%)	N/A
N/A	Painted X Walk1?	No	N/A	Painted X Walk2?	N/A
	X Walk 1 Direction	To SE		X Walk 2 Direction	N/A
N/A	X Walk 1 Width (in)	N/A	N/A	X Walk 2 Width (in)	N/A
	X Walk 1 Slope (%)	2.1		X Walk 2 Slope (%)	N/A
	X Walk 1 X Slope (%)	0.0		X Walk 2 X Slope (%)	N/A

N/A	Ramp inside XWalk1?	N/A	N/A	Ramp inside XWalk2?	N/A
	Road Slope (%)	N/A	N/A	Clear Space?	N/A
	Road X Slope (%)	N/A	N/A	Clear Space to XWalk (in)	N/A
N/A	Any Obstructions?	N/A	N/A	Storm Grate/Utility Hazard?	N/A
	Obstruction Type			Storm Grate/Utility Type	
		N/A			N/A
			Yes	Surface Condition? (G/P)	Good

Possible Solutions:

Remove & Replace Entire Ramp.

Total Cost: \$ 1850.00
