# Access Compliance Report Public Rights-of-Way (Curb Ramps)

Intersection ID: 5468      Main Street: N\_TRYON\_ST      Cross Street: J\_W\_CLAY\_BV      Location: S

ADA ID: 80FA5E2F2670      Ramp Type: Perp      Initial Pass/Fail: Fail      Overall Compliance: No      Severity Score: 22.5

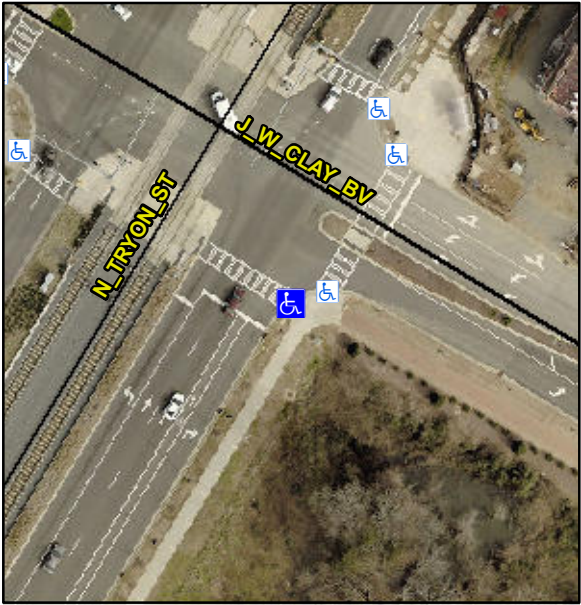
PROW/ADA:  
**R304.5.1, R304.2.2, R304.5.3**

Compliance	Description	Data	Compliance	Description	Data
N/A	Ramp Length (in)	97.0	No	Ramp Slope (%)	10.2
No	Ramp Width (in)	47.5	No	Ramp XSlope (%)	2.7
N/A	Flare Type LT	N/A	N/A	Flare Type RT	N/A
N/A	Flare Slope LT (%)	N/A	N/A	Flare Slope RT (%)	N/A
N/A	Flare Traversable LT?	N/A	N/A	Flare Traversable RT?	N/A
N/A	Landing Length (in)	N/A	N/A	DWS Provided?	N/A
N/A	Landing Width (in)	N/A	N/A	DWS Contrast?	N/A
N/A	Landing Slope (%)	N/A	N/A	DWS Length (in)	N/A
N/A	Landing X Slope (%)	N/A	N/A	DWS Full Width?	N/A
N/A	Landing Curb? (Y/N)	N/A	N/A	DWS Offset (in)	N/A
N/A	Shared Landing?	N/A			
N/A	Gutter Ponding?	N/A	N/A	Gutter Slope (%)	N/A
N/A	Gutter Lip Ht (in)	N/A	N/A	Gutter X Slope (%)	N/A
N/A	Painted X Walk1?	No	N/A	Painted X Walk2?	N/A
	X Walk 1 Direction	To NW		X Walk 2 Direction	N/A
N/A	X Walk 1 Width (in)	N/A	N/A	X Walk 2 Width (in)	N/A
	X Walk 1 Slope (%)	2.9		X Walk 2 Slope (%)	N/A
	X Walk 1 X Slope (%)	1.1		X Walk 2 X Slope (%)	N/A

Possible Solutions:  
**Remove & Replace Entire Ramp.**
