Access Compliance Report

Public Rights-of-Way

(Curb Ramps)

Intersection ID: 10035937	Main Street: RICHLAND_DR	Cross Street: N/A	Location: S
ADA ID: 810109ADBE3B	Ramp Type: PerpDiag	Initial Pass/Fail: Fail	Overall Compliance: No
		Severity Score: 25

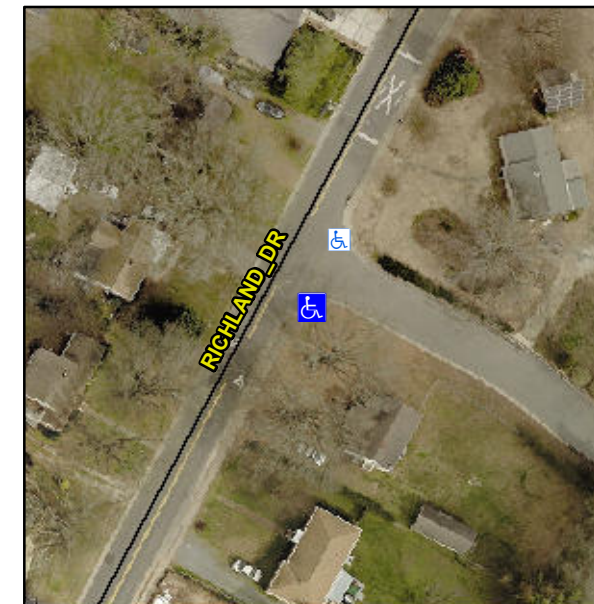
Not Found, R304.2.2

Compliance	Description	Data	Compliance	Description	Data
N/A	Ramp Length (in)	53.0	No	Ramp Slope (%)	14.8
Yes	Ramp Width (in)	48.0	Yes	Ramp XSlope (%)	2.0
N/A	Flare Type LT	N/A	N/A	Flare Type RT	N/A
N/A	Flare Slope LT (%)	N/A	N/A	Flare Slope RT (%)	N/A
N/A	Flare Traversable LT?	N/A	N/A	Flare Traversable RT?	N/A
N/A	Landing Length (in)	N/A	N/A	DWS Provided?	N/A
N/A	Landing Width (in)	N/A	N/A	DWS Contrast?	N/A
N/A	Landing Slope (%)	N/A	N/A	DWS Length (in)	N/A
N/A	Landing X Slope (%)	N/A	N/A	DWS Full Width?	N/A
N/A	Landing Curb? (Y/N)	N/A	N/A	DWS Offset (in)	N/A
N/A	Shared Landing?	N/A			
N/A	Gutter Ponding?	N/A	N/A	Gutter Slope (%)	N/A
N/A	Gutter Lip Ht (in)	N/A	N/A	Gutter X Slope (%)	N/A
N/A	Painted X Walk1?	No	N/A	Painted X Walk2?	No
	X Walk 1 Direction	To NE		X Walk 2 Direction	To NW
N/A	X Walk 1 Width (in)	N/A	N/A	X Walk 2 Width (in)	N/A
	X Walk 1 Slope (%)	3.5		X Walk 2 Slope (%)	7.7
	X Walk 1 X Slope (%)	8.8		X Walk 2 X Slope (%)	2.0

N/A	Ramp inside XWalk1?	N/A	N/A	Ramp inside XWalk2?	N/A
	Road Slope (%)	0.1	N/A	Clear Space?	N/A
	Road X Slope (%)	8.9	N/A	Clear Space to XWalk (in)	N/A
N/A	Any Obstructions?	N/A	N/A	Storm Grate/Utility Hazard?	N/A
	Obstruction Type			Storm Grate/Utility Type	
		N/A			N/A
			Yes	Surface Condition? (G/P)	Good

Remove & Replace Curb Ramp With Two New Directional Ramps or Equivalent.

Total Cost: \$ 3200.00
