Access Compliance Report

Public Rights-of-Way

(Curb Ramps)

Intersection ID: 27121	Main Street: ELM_LN	Cross Street: ENDAHVEN_LN	Location: SW
ADA ID: 8108359F8AEB	Ramp Type: Para	Initial Pass/Fail: Fail	Overall Compliance: No
			Severity Score: 21.25

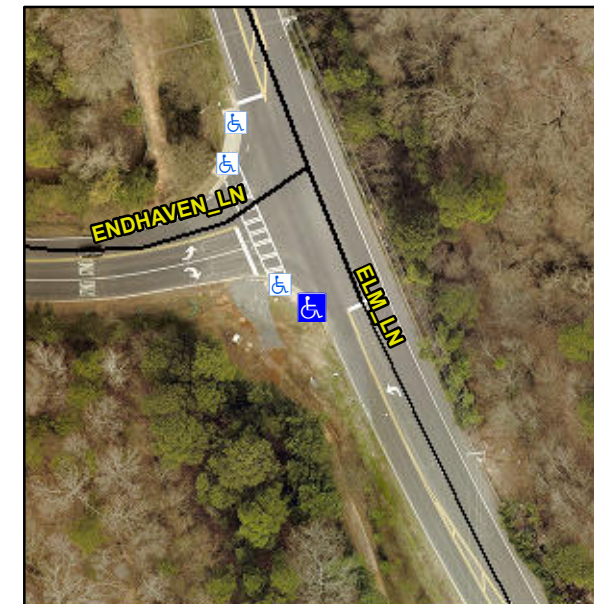
RT RP < 5%

R304.5.1, R304.3.2

Compliance	Description	Data	Compliance	Description	Data
N/A	Ramp Length LT (in)	64.0	N/A	Ramp Length RT (in)	65.5
No	Ramp Width LT (in)	42.0	No	Ramp Width RT (in)	42.0
No	Ramp Slope LT (%)	8.4	Yes	Ramp Slope RT (%)	4.3
Yes	Ramp XSlope LT (%)	2.0	Yes	Ramp XSlope RT (%)	1.7
N/A	Landing Length (in)	N/A	N/A	DWS Provided?	N/A
N/A	Landing Width (in)	N/A	N/A	DWS Contrast?	N/A
N/A	Landing Slope (%)	N/A	N/A	DWS Length (in)	N/A
N/A	Landing X Slope (%)	N/A	N/A	DWS Full Width?	N/A
N/A	Landing Curb? (Y/N)	N/A	N/A	DWS Offset (in)	N/A
N/A	Shared Landing?	N/A			
N/A	Gutter Ponding?	N/A	N/A	Gutter Slope (%)	N/A
N/A	Gutter Lip Ht (in)	N/A	N/A	Gutter X Slope (%)	N/A
N/A	Painted X Walk1?	No	N/A	Painted X Walk2?	N/A
	X Walk 1 Direction	To NE		X Walk 2 Direction	N/A
N/A	X Walk 1 Width (in)	N/A	N/A	X Walk 2 Width (in)	N/A
	X Walk 1 Slope (%)	1.3		X Walk 2 Slope (%)	N/A
	X Walk 1 X Slope (%)	2.3		X Walk 2 X Slope (%)	N/A
N/A	Ramp inside XWalk1?	N/A	N/A	Ramp inside XWalk2?	N/A

Road Slope (%)	N/A	N/A	Clear Space?	N/A
	Road X Slope (%)	N/A	N/A	Clear Space to XWalk (in)	N/A
N/A	Any Obstructions?	N/A	N/A	Storm Grate/Utility Hazard?	N/A
	Obstruction Type			Storm Grate/Utility Type	
		N/A			N/A
			Yes	Surface Condition? (G/P)	Good
			N/A	Curb Slope (%)	5.2

Remove & Replace Entire Ramp.
