Access Compliance Report

Public Rights-of-Way

(Curb Ramps)

Intersection ID: 11992	Main Street: W_MOREHEAD_ST	Cross Street: GRANDIN_RD	Location: NE
ADA ID: 8116E93D76C8	Ramp Type: BlendTrans1	Initial Pass/Fail: Fail	Overall Compliance: No
		Severity Score: 1.25

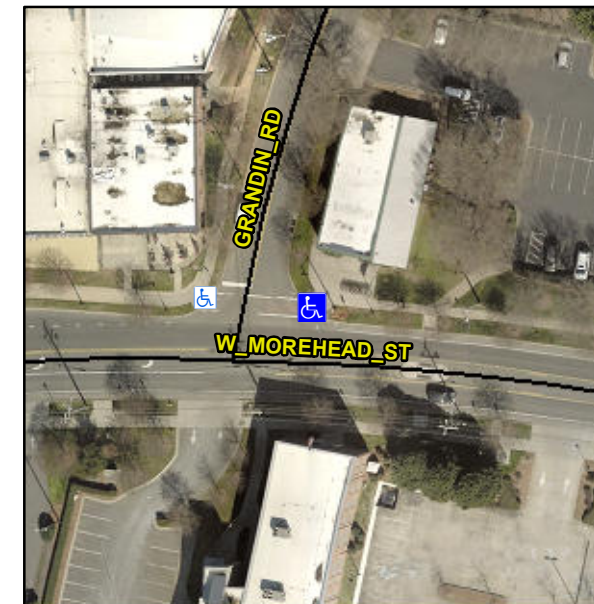
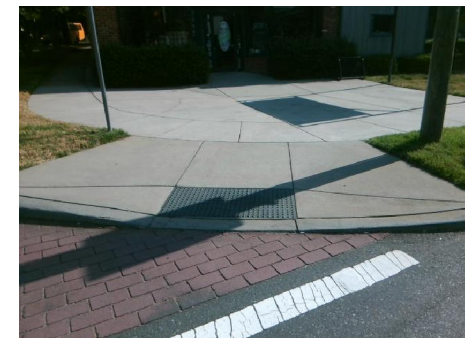
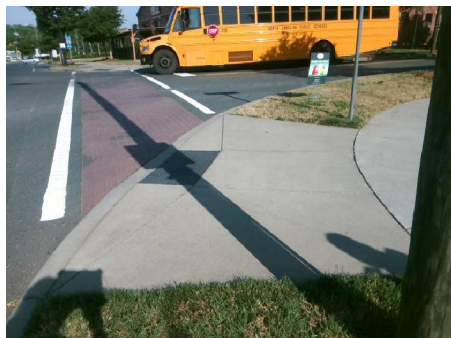
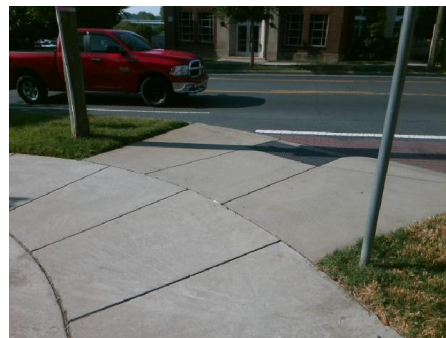
Compliance	Description	Data	Compliance	Description	Data
N/A	Ramp Length (in)	93.0	Yes	BlendTrans Slope (%)	3.2
Yes	Ramp Width (in)	48.0	No	BlendTrans XSlope (%)	3.1
N/A	Flare Type LT	N/A	N/A	Flare Type RT	N/A
N/A	Flare Slope LT (%)	N/A	N/A	Flare Slope RT (%)	N/A
N/A	Flare Traversable LT?	N/A	N/A	Flare Traversable RT?	N/A
N/A	Landing Length (in)	N/A	N/A	DWS Provided?	N/A
N/A	Landing Width (in)	N/A	N/A	DWS Contrast?	N/A
N/A	Landing Slope (%)	N/A	N/A	DWS Length (in)	N/A
N/A	Landing X Slope (%)	N/A	N/A	DWS Full Width?	N/A
N/A	Landing Curb? (Y/N)	N/A	N/A	DWS Offset (in)	N/A
N/A	Shared Landing?	N/A			
N/A	Gutter Ponding?	N/A	N/A	Gutter Slope (%)	N/A
N/A	Gutter Lip Ht (in)	N/A	N/A	Gutter X Slope (%)	N/A
N/A	Painted X Walk1?	Yes	N/A	Painted X Walk2?	N/A
	X Walk 1 Direction	To W		X Walk 2 Direction	N/A
	X Walk 1 Width (in)	100.0		X Walk 2 Width (in)	N/A
	X Walk 1 Slope (%)	3.3		X Walk 2 Slope (%)	N/A
	X Walk 1 X Slope (%)	1.6		X Walk 2 X Slope (%)	N/A

N/A	Ramp inside XWalk1?	Yes	N/A	Ramp inside XWalk2?	N/A
	Road Slope (%)	1.6		Clear Space?	N/A
	Road X Slope (%)	3.3	N/A	Clear Space to XWalk (in)	N/A
N/A	Any Obstructions?	N/A	N/A	Storm Grate/Utility Hazard?	N/A
	Obstruction Type			Storm Grate/Utility Type	
		N/A			N/A
			Yes	Surface Condition? (G/P)	Good
			N/A	Curb Slope (%)	0.2

Remove & Replace Curb Ramp With Two New Directional Ramps or Equivalent.

R304.5.3

\$ 3200.00
