# Access Compliance Report

## Public Rights-of-Way

### (Curb Ramps)

| Intersection ID: 2549 | Main Street: BEARDSLEY_DR | Cross Street: MCCHESENEY_DR | Location: E |

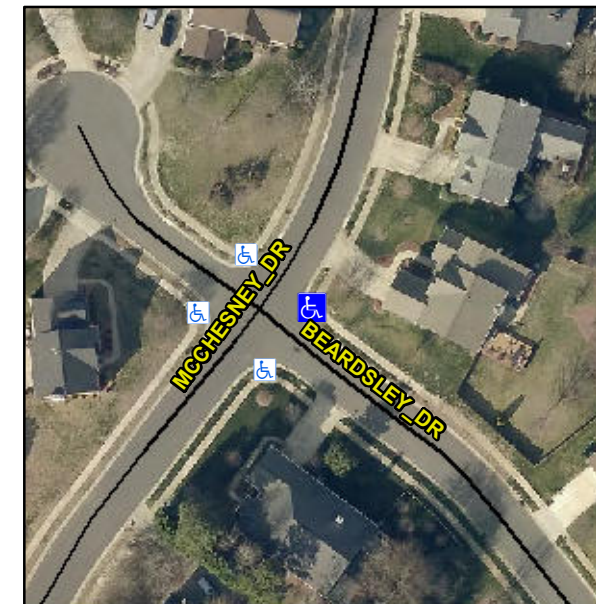
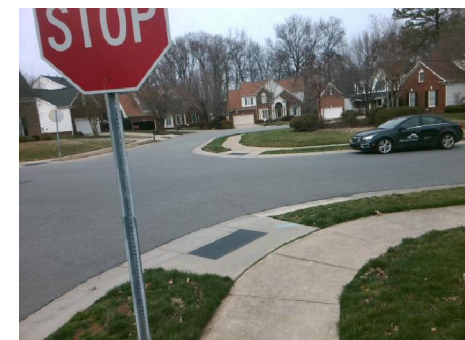
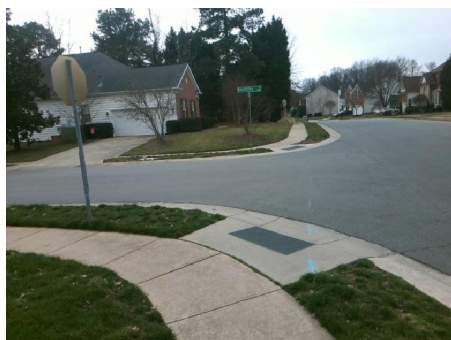
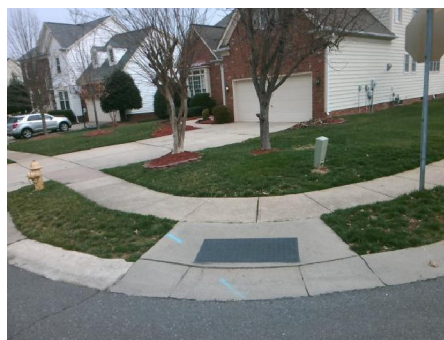
| ADA ID: 81185E6DBAF1 | Ramp Type: BlendTrans1 | Initial Pass/Fail: Pass | Overall Compliance: No |

**R305.2, R302.7.2, R304.5.3**

| Compliance | Description | Data | Compliance | Description | Data |
|---|---|---|---|---|---|
| N/A | Landing Curb? (Y/N) | No | No | DWS Offset (in) | 3.0 |
| No | Gutter Lip Ht (in) | 0.5 | No | Gutter X Slope (%) | 2.5 |

**Remove & Replace Detectable Warning System. Remove & Replace Gutter.**

Total Cost: \$ 1550.00
