Access Compliance Report Public Rights-of-Way (Curb Ramps)

Intersection ID: 11140 Main Street: N SYCAMORE ST Cross Street: W_5TH_ST Location:

ADA ID: 8119375DBE22 Ramp Type: PerpDiag Initial Pass/Fail: Fail **Overall Compliance: No** Severity Score: 48.75

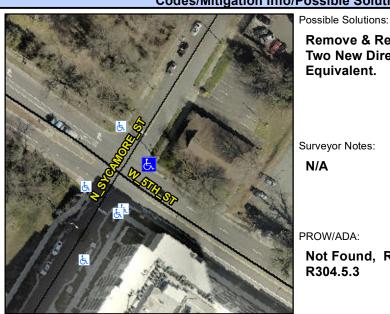
10.8

3.2

24.0 No

Not Found, R304.5.1, R304.2.2, R304.5.3

Remove & Replace Curb Ramp With Two New Directional Ramps or Equivalent.

Total Cost: 3200.00
