Access Compliance Report

Public Rights-of-Way

(Curb Ramps)

Intersection ID: 17141	Main Street: PARK_RD	Cross Street: WYNDCROFTE_PL	Location: SW
ADA ID: 811CDB611CCC	Ramp Type: PerpDiag	Initial Pass/Fail: Pass	Overall Compliance: No
			Severity Score: 10.25

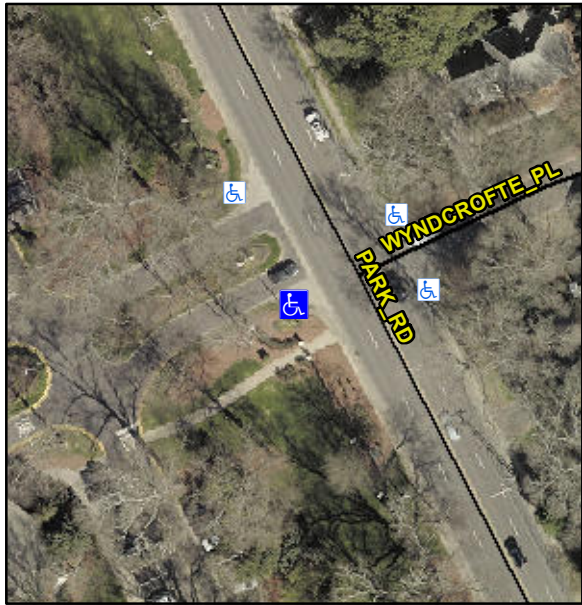
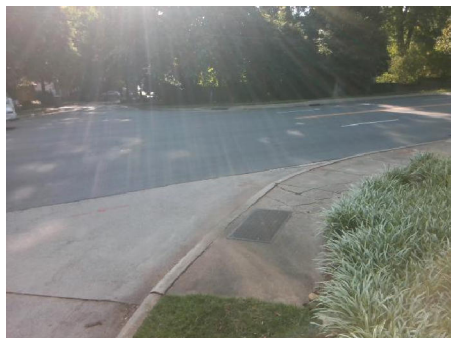
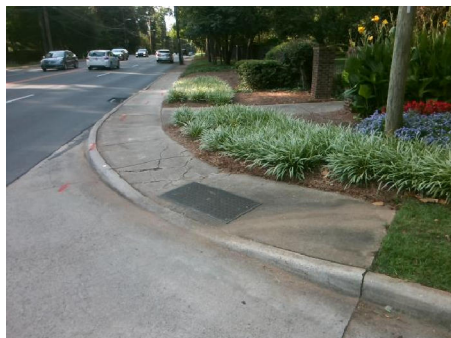
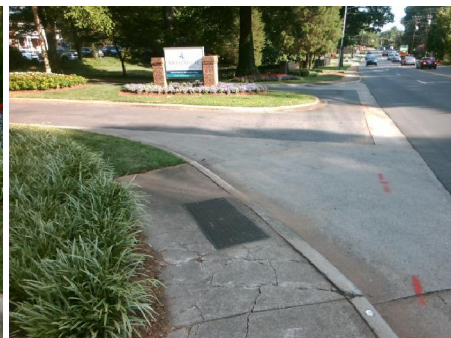
Possible Solutions:		Compliance	Description	Data	Compliance	Description	Data
	Remove & Replace Curb Ramp With Two New Directional Ramps or Equivalent.		N/A	Ramp Length (in)	48.0	Yes	Ramp Slope (%)	6.8
			Yes	Ramp Width (in)	48.0	No	Ramp XSlope (%)	2.2
			N/A	Flare Type LT	Sloped	N/A	Flare Type RT	N/A
			N/A	Flare Slope LT (%)	8.3	N/A	Flare Slope RT (%)	6.6
			N/A	Flare Traversable LT?	Yes	N/A	Flare Traversable RT?	No
			No	Landing Length (in)	N/A	Yes	DWS Provided?	Yes
			No	Landing Width (in)	N/A	Yes	DWS Contrast?	Yes
			No	Landing Slope (%)	N/A	Yes	DWS Length (in)	24.0
			No	Landing X Slope (%)	N/A	Yes	DWS Full Width?	Yes
		N/A	Landing Curb? (Y/N)	No	No	DWS Offset (in)	6.0	
		N/A	Shared Landing?	N/A				
		Yes	Gutter Ponding?	No	Yes	Gutter Slope (%)	2.2	
		Yes	Gutter Lip Ht (in)	0.0	Yes	Gutter X Slope (%)	1.1	
		N/A	Painted X Walk1?	No	N/A	Painted X Walk2?	No

X Walk 1 Direction	To E		X Walk 2 Direction	To NE	
		N/A	X Walk 1 Width (in)	N/A	N/A	X Walk 2 Width (in)	N/A	
			X Walk 1 Slope (%)	2.7		X Walk 2 Slope (%)	4.3	
			X Walk 1 X Slope (%)	2.2		X Walk 2 X Slope (%)	3.5	
		N/A	Ramp inside XWalk1?	N/A	N/A	Ramp inside XWalk2?	N/A	
			Road Slope (%)	1.4	N/A	Clear Space?	Yes	
			Road X Slope (%)	4.7	N/A	Clear Space to XWalk (in)	N/A	
		Yes	Any Obstructions?	No	Yes	Storm Grate/Utility Hazard?	No	
			Obstruction Type			Storm Grate/Utility Type		
				N/A			N/A	
					Yes	Surface Condition? (G/P)	Good
