Access Compliance Report

Public Rights-of-Way

(Curb Ramps)

Intersection ID: 10639	Main Street: SLOAN_DR	Cross Street: QUEEN_CITY_DR	Location: E
ADA ID: 811D2BCC8A15	Ramp Type: Perp	Initial Pass/Fail: Fail	Overall Compliance: No
			Severity Score: 21.25

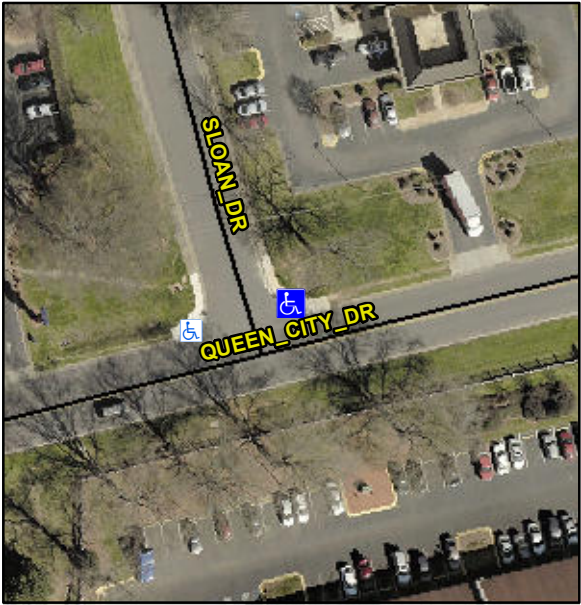
Possible Solutions:		Compliance	Description	Data
	Remove & Replace Entire Ramp.		No	Ramp Length (in)	52.0
			No	Ramp Width (in)	40.0
			N/A	Flare Type LT	N/A
			N/A	Flare Slope LT (%)	N/A
			N/A	Flare Traversable LT?	N/A
			N/A	Landing Length (in)	N/A
			N/A	Landing Width (in)	N/A
			N/A	Landing Slope (%)	N/A
			N/A	Landing X Slope (%)	N/A
<p>Surveyor Notes:</p> <p>N/A</p> <p>PROW/ADA:</p> <p>Not Found, R304.5.1, R304.2.2</p>			N/A	Flare Type RT	N/A
			N/A	Flare Slope RT (%)	N/A
			N/A	Flare Traversable RT?	N/A
			N/A	DWS Provided?	N/A
			N/A	DWS Contrast?	N/A
			N/A	DWS Length (in)	N/A
			N/A	DWS Full Width?	N/A
			N/A	DWS Offset (in)	N/A
			N/A	Shared Landing?	N/A
			N/A	Gutter Ponding?	N/A
			N/A	Gutter Lip Ht (in)	0.5
			N/A	Painted X Walk1?	No
				X Walk 1 Direction	To W
			N/A	X Walk 1 Width (in)	N/A
				X Walk 1 Slope (%)	3.1

X Walk 1 X Slope (%)	0.5
			N/A	Ramp inside XWalk1?	N/A
			N/A	Road Slope (%)	N/A
			N/A	Road X Slope (%)	N/A
			N/A	Any Obstructions?	N/A
Total Cost:		\$ 1850.00		Obstruction Type	
			N/A		
			N/A		
			Yes	Surface Condition? (G/P)	Good
