Access Compliance Report

Public Rights-of-Way

(Curb Ramps)

Intersection ID: 18459	Main Street: ABBEY_PL	Cross Street: HEDGEMORE DR	Location: SE
ADA ID: 81234A048F4B	Ramp Type: PerpDiag	Initial Pass/Fail: Fail	Overall Compliance: No
Severity Score: 12.5			
Codes/Mitigation Info/Possible Solution		Field Measurements/Component Compliance

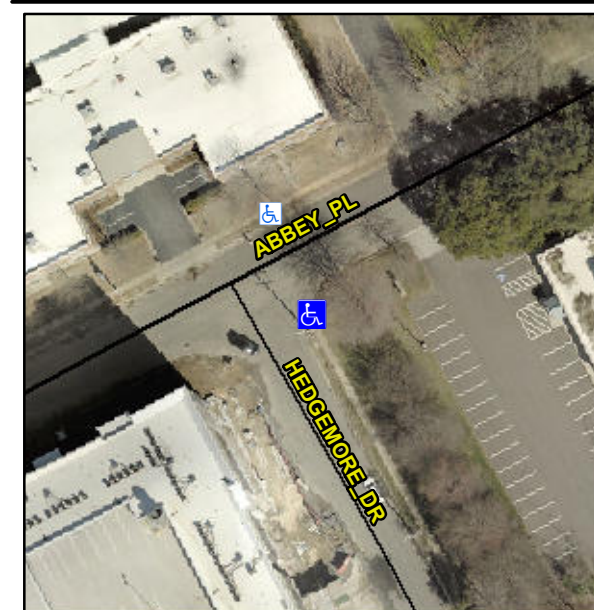
Compliance	Description	Data	Compliance	Description	Data
N/A	Ramp Length (in)	25.0	Yes	Ramp Slope (%)	5.5
Yes	Ramp Width (in)	48.0	No	Ramp XSlope (%)	6.6
N/A	Flare Type LT	N/A	N/A	Flare Type RT	N/A
N/A	Flare Slope LT (%)	N/A	N/A	Flare Slope RT (%)	N/A
N/A	Flare Traversable LT?	N/A	N/A	Flare Traversable RT?	N/A
N/A	Landing Length (in)	N/A	N/A	DWS Provided?	N/A
N/A	Landing Width (in)	N/A	N/A	DWS Contrast?	N/A
N/A	Landing Slope (%)	N/A	N/A	DWS Length (in)	N/A
N/A	Landing X Slope (%)	N/A	N/A	DWS Full Width?	N/A
N/A	Landing Curb? (Y/N)	N/A	N/A	DWS Offset (in)	N/A
N/A	Shared Landing?	N/A			
N/A	Gutter Ponding?	N/A	N/A	Gutter Slope (%)	N/A
N/A	Gutter Lip Ht (in)	1.5	N/A	Gutter X Slope (%)	N/A
N/A	Painted X Walk1?	No	N/A	Painted X Walk2?	No
	X Walk 1 Direction	To N		X Walk 2 Direction	To W
N/A	X Walk 1 Width (in)	N/A	N/A	X Walk 2 Width (in)	N/A
	X Walk 1 Slope (%)	1.8		X Walk 2 Slope (%)	5.9
	X Walk 1 X Slope (%)	0.9		X Walk 2 X Slope (%)	4.0

N/A	Ramp inside XWalk1?	N/A	N/A	Ramp inside XWalk2?	N/A
	Road Slope (%)	1.9	N/A	Clear Space?	N/A
	Road X Slope (%)	3.8	N/A	Clear Space to XWalk (in)	N/A
N/A	Any Obstructions?	N/A	N/A	Storm Grate/Utility Hazard?	N/A
	Obstruction Type			Storm Grate/Utility Type	
		N/A			N/A
		Yes		Surface Condition? (G/P)	Good

Possible Solutions:

Remove & Replace Curb Ramp With Two New Directional Ramps or Equivalent.

R304.5.3
