Intersection ID: 10025130	Main Street: DRUM_ST	Cross Street: N/A	Location:	N/A
ADA ID: 81244D55BEA5	Ramp Type: Perp	Initial Pass/Fail: Fail	Overall Compliance: No	Severity Score: 33.75

Street 1 Name	DRUM STREET
Stop Condition-Street 2	None
Street 2 Name	N/A
Stop Condition-Street 1	N/A

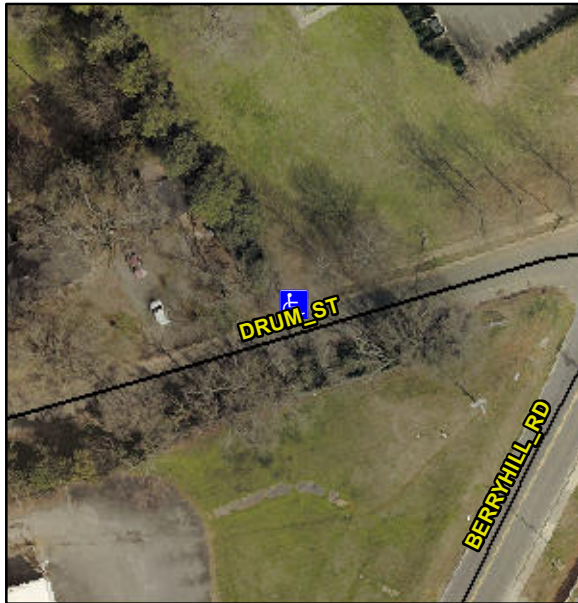
Not Found, R304.5.1, R304.2.2

Compliance	Description	Data	Compliance	Description	Data
N/A	Ramp Length (in)	50.0	No	Ramp Slope (%)	12.7
No	Ramp Width (in)	47.5	Yes	Ramp XSlope (%)	1.4
N/A	Flare Type LT	N/A	N/A	Flare Type RT	N/A
N/A	Flare Slope LT (%)	N/A	N/A	Flare Slope RT (%)	N/A
N/A	Flare Traversable LT?	N/A	N/A	Flare Traversable RT?	N/A
N/A	Landing Length (in)	N/A	N/A	DWS Provided?	N/A
N/A	Landing Width (in)	N/A	N/A	DWS Contrast?	N/A
N/A	Landing Slope (%)	N/A	N/A	DWS Length (in)	N/A
N/A	Landing X Slope (%)	N/A	N/A	DWS Full Width?	N/A
N/A	Landing Curb? (Y/N)	N/A	N/A	DWS Offset (in)	N/A
N/A	Shared Landing?	N/A			
N/A	Gutter Ponding?	N/A	N/A	Gutter Slope (%)	N/A
N/A	Gutter Lip Ht (in)	0.5	N/A	Gutter X Slope (%)	N/A
N/A	Painted X Walk1?	No	N/A	Painted X Walk2?	N/A
	X Walk 1 Direction	To S		X Walk 2 Direction	N/A
N/A	X Walk 1 Width (in)	N/A	N/A	X Walk 2 Width (in)	N/A
	X Walk 1 Slope (%)	2.3		X Walk 2 Slope (%)	N/A
	X Walk 1 X Slope (%)	0.4		X Walk 2 X Slope (%)	N/A

N/A	Ramp inside XWalk1?	N/A	N/A	Ramp inside XWalk2?	N/A
	Road Slope (%)	0.4	N/A	Clear Space?	N/A
	Road X Slope (%)	2.3	N/A	Clear Space to XWalk (in)	N/A
N/A	Any Obstructions?	N/A	N/A	Storm Grate/Utility Hazard?	N/A
	Obstruction Type			Storm Grate/Utility Type	
		N/A			N/A
			Yes	Surface Condition? (G/P)	Good

Remove & Replace Entire Ramp.
