Intersection ID: 10033939	Main Street: PARK_RD	Cross Street: N/A	Location:	SE
ADA ID: 81252B2D993F	Ramp Type: BlendTrans1	Initial Pass/Fail: Fail	Overall Compliance: No	Severity Score: 15

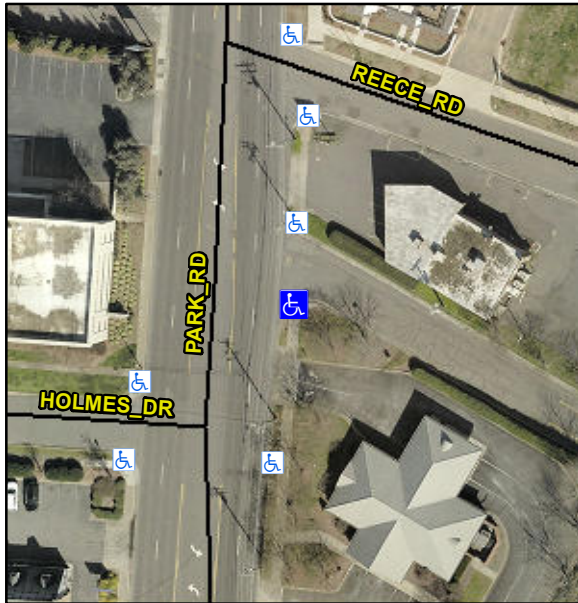
Compliance	Description	Data	Compliance	Description	Data
N/A	Ramp Length (in)	66.0	Yes	BlendTrans Slope (%)	3.6
Yes	Ramp Width (in)	72.0	Yes	BlendTrans XSlope (%)	1.6
N/A	Flare Type LT	N/A	N/A	Flare Type RT	N/A
N/A	Flare Slope LT (%)	N/A	N/A	Flare Slope RT (%)	N/A
N/A	Flare Traversable LT?	N/A	N/A	Flare Traversable RT?	N/A
N/A	Landing Length (in)	N/A	N/A	DWS Provided?	N/A
N/A	Landing Width (in)	N/A	N/A	DWS Contrast?	N/A
N/A	Landing Slope (%)	N/A	N/A	DWS Length (in)	N/A
N/A	Landing X Slope (%)	N/A	N/A	DWS Full Width?	N/A
N/A	Landing Curb? (Y/N)	N/A	N/A	DWS Offset (in)	N/A
N/A	Shared Landing?	N/A			
N/A	Gutter Ponding?	N/A	N/A	Gutter Slope (%)	N/A
N/A	Gutter Lip Ht (in)	N/A	N/A	Gutter X Slope (%)	N/A
N/A	Painted X Walk1?	No	N/A	Painted X Walk2?	N/A
	X Walk 1 Direction	To N		X Walk 2 Direction	N/A
	X Walk 1 Width (in)	N/A		X Walk 2 Width (in)	N/A
	X Walk 1 Slope (%)	1.0		X Walk 2 Slope (%)	N/A
	X Walk 1 X Slope (%)	1.8		X Walk 2 X Slope (%)	N/A

N/A	Ramp inside XWalk1?	N/A	N/A	Ramp inside XWalk2?	N/A
	Road Slope (%)	1.8		Clear Space?	N/A
	Road X Slope (%)	1.0	N/A	Clear Space to XWalk (in)	N/A
N/A	Any Obstructions?	N/A	N/A	Storm Grate/Utility Hazard?	N/A
	Obstruction Type			Storm Grate/Utility Type	
		N/A			N/A
			No	Surface Condition? (G/P)	Poor
			Yes	Curb Slope (%)	4.2

**Remove & Replace Curb Ramp With Two New Directional Ramps or Equivalent.**
