# Access Compliance Report

## Public Rights-of-Way

### (Curb Ramps)

Intersection ID: 24241	Main Street: KANFER_CT	Cross Street: PIMA_COTTON_DR	Location: NW
ADA ID: 814083AA7BEB	Ramp Type: BlendTrans2	Initial Pass/Fail: Pass	Overall Compliance: No
		Severity Score: 10.25

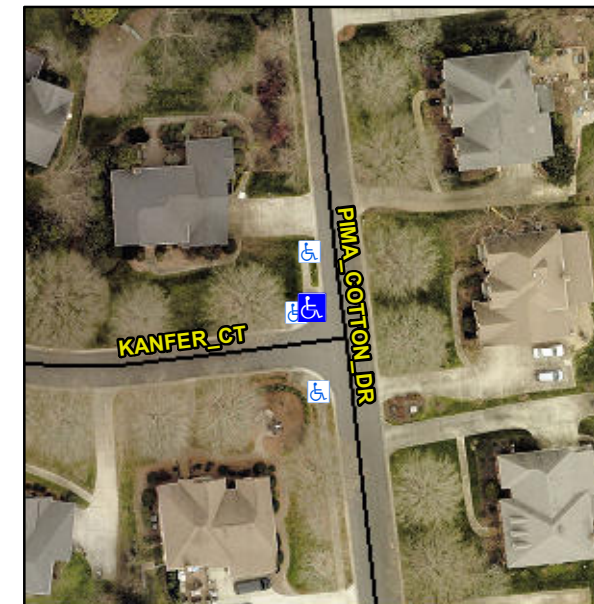
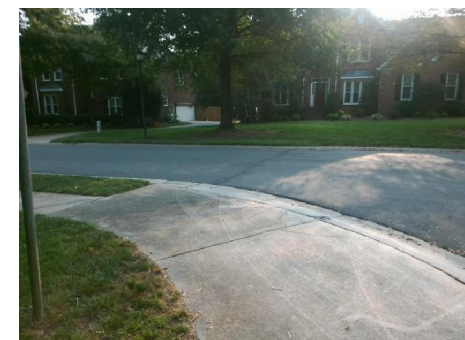
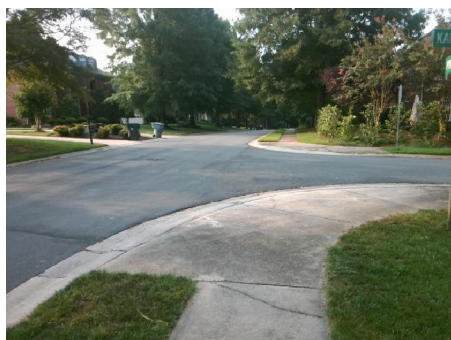
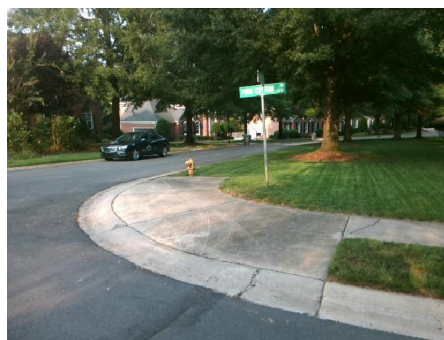
Compliance	Description	Data	Compliance	Description	Data
N/A	Ramp Length (in)	96.0	Yes	BlendTrans Slope (%)	4.5
Yes	Ramp Width (in)	48.0	No	BlendTrans XSlope (%)	3.6
N/A	Flare Type LT	None	N/A	Flare Type RT	None
N/A	Flare Slope LT (%)	N/A	N/A	Flare Slope RT (%)	N/A
N/A	Flare Traversable LT?	N/A	N/A	Flare Traversable RT?	N/A
N/A	Landing Length (in)	N/A	No	DWS Provided?	No
N/A	Landing Width (in)	N/A	N/A	DWS Contrast?	No
N/A	Landing Slope (%)	N/A	N/A	DWS Length (in)	N/A
N/A	Landing X Slope (%)	N/A	N/A	DWS Full Width?	No
N/A	Landing Curb? (Y/N)	No	N/A	DWS Offset (in)	N/A
N/A	Shared Landing?	No			
Yes	Gutter Ponding?	No	Yes	Gutter Slope (%)	2.6
Yes	Gutter Lip Ht (in)	0.0	Yes	Gutter X Slope (%)	0.8
N/A	Painted X Walk1?	No	N/A	Painted X Walk2?	N/A
	X Walk 1 Direction	To E		X Walk 2 Direction	N/A
	X Walk 1 Width (in)	N/A		X Walk 2 Width (in)	N/A
	X Walk 1 Slope (%)	2.6		X Walk 2 Slope (%)	N/A
	X Walk 1 X Slope (%)	0.6		X Walk 2 X Slope (%)	N/A

N/A	Ramp inside XWalk1?	N/A	N/A	Ramp inside XWalk2?	N/A
	Road Slope (%)	0.6		Clear Space?	Yes
	Road X Slope (%)	2.6	N/A	Clear Space to XWalk (in)	N/A
Yes	Any Obstructions?	No	Yes	Storm Grate/Utility Hazard?	No
	Obstruction Type			Storm Grate/Utility Type	
			N/A		N/A
			Yes	Surface Condition? (G/P)	Good
			N/A	Curb Slope (%)	0.1

**Remove & Replace Curb Ramp With Two New Directional Ramps or Equivalent.**

**R304.5.3, R305**

Total Cost: \$ 3200.00
