Access Compliance Report

Public Rights-of-Way

(Curb Ramps)

Intersection ID: 13719	Main Street: CENTRAL_AV	Cross Street: CAROLYN_DR	Location: SE
ADA ID: 8156838F8510	Ramp Type: Perp	Initial Pass/Fail: Fail	Overall Compliance: No
Severity Score: 22.5			
Codes/Mitigation Info/Possible Solution		Field Measurements/Component Compliance

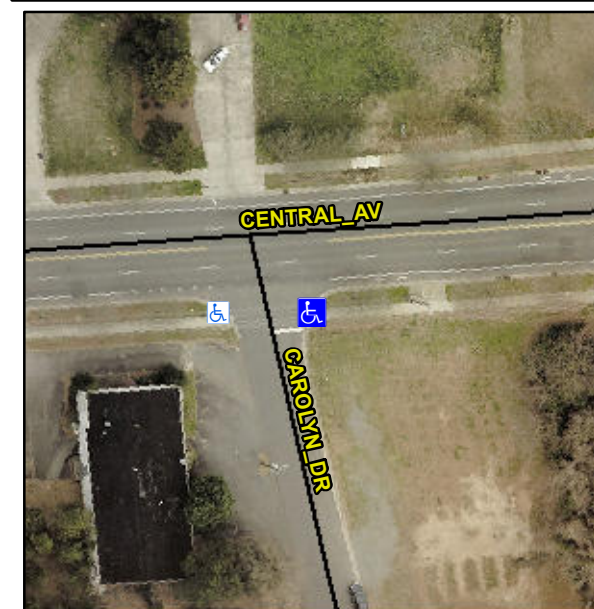
Not Found, R304.5.1, R304.2.2, R304.5.3

Compliance	Description	Data	Compliance	Description	Data
N/A	Ramp Length (in)	72.0	No	Ramp Slope (%)	11.2
No	Ramp Width (in)	37.5	No	Ramp XSlope (%)	4.5
N/A	Flare Type LT	N/A	N/A	Flare Type RT	N/A
N/A	Flare Slope LT (%)	N/A	N/A	Flare Slope RT (%)	N/A
N/A	Flare Traversable LT?	N/A	N/A	Flare Traversable RT?	N/A
N/A	Landing Length (in)	N/A	N/A	DWS Provided?	N/A
N/A	Landing Width (in)	N/A	N/A	DWS Contrast?	N/A
N/A	Landing Slope (%)	N/A	N/A	DWS Length (in)	N/A
N/A	Landing X Slope (%)	N/A	N/A	DWS Full Width?	N/A
N/A	Landing Curb? (Y/N)	N/A	N/A	DWS Offset (in)	N/A
N/A	Shared Landing?	N/A			
N/A	Gutter Ponding?	N/A	N/A	Gutter Slope (%)	N/A
N/A	Gutter Lip Ht (in)	N/A	N/A	Gutter X Slope (%)	N/A
N/A	Painted X Walk1?	No	N/A	Painted X Walk2?	N/A
	X Walk 1 Direction	To W		X Walk 2 Direction	N/A
N/A	X Walk 1 Width (in)	N/A	N/A	X Walk 2 Width (in)	N/A
	X Walk 1 Slope (%)	2.7		X Walk 2 Slope (%)	N/A
	X Walk 1 X Slope (%)	7.8		X Walk 2 X Slope (%)	N/A

N/A	Ramp inside XWalk1?	N/A	N/A	Ramp inside XWalk2?	N/A
	Road Slope (%)	N/A	N/A	Clear Space?	N/A
	Road X Slope (%)	N/A	N/A	Clear Space to XWalk (in)	N/A
N/A	Any Obstructions?	N/A	N/A	Storm Grate/Utility Hazard?	N/A
	Obstruction Type			Storm Grate/Utility Type	
		N/A			N/A
			Yes	Surface Condition? (G/P)	Good

Possible Solutions:

Remove & Replace Entire Ramp.
