# Access Compliance Report

## Public Rights-of-Way

### (Curb Ramps)

Intersection ID: N/A	Main Street: WOODLAWN_ST	Cross Street: N/A	Location: S
ADA ID: 815A45DC4394	Ramp Type: Perp	Initial Pass/Fail: Fail	Overall Compliance: No
Severity Score: 12.5			
Codes/Mitigation Info/Possible Solution		Field Measurements/Component Compliance

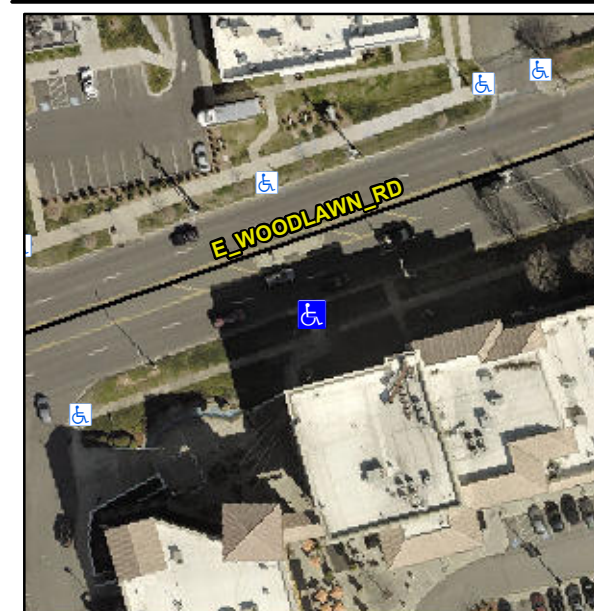
**Not Found, R304.2.2**

Compliance	Description	Data	Compliance	Description	Data
N/A	Ramp Length (in)	145.0	No	Ramp Slope (%)	11.4
Yes	Ramp Width (in)	61.0	Yes	Ramp XSlope (%)	0.8
N/A	Flare Type LT	N/A	N/A	Flare Type RT	N/A
N/A	Flare Slope LT (%)	N/A	N/A	Flare Slope RT (%)	N/A
N/A	Flare Traversable LT?	N/A	N/A	Flare Traversable RT?	N/A
N/A	Landing Length (in)	N/A	N/A	DWS Provided?	N/A
N/A	Landing Width (in)	N/A	N/A	DWS Contrast?	N/A
N/A	Landing Slope (%)	N/A	N/A	DWS Length (in)	N/A
N/A	Landing X Slope (%)	N/A	N/A	DWS Full Width?	N/A
N/A	Landing Curb? (Y/N)	N/A	N/A	DWS Offset (in)	N/A
N/A	Shared Landing?	N/A			
N/A	Gutter Ponding?	N/A	N/A	Gutter Slope (%)	N/A
N/A	Gutter Lip Ht (in)	N/A	N/A	Gutter X Slope (%)	N/A
N/A	Painted X Walk1?	No	N/A	Painted X Walk2?	N/A
	X Walk 1 Direction	To N		X Walk 2 Direction	N/A
N/A	X Walk 1 Width (in)	N/A	N/A	X Walk 2 Width (in)	N/A
	X Walk 1 Slope (%)	7.5		X Walk 2 Slope (%)	N/A
	X Walk 1 X Slope (%)	4.6		X Walk 2 X Slope (%)	N/A

N/A	Ramp inside XWalk1?	N/A	N/A	Ramp inside XWalk2?	N/A
	Road Slope (%)	N/A	N/A	Clear Space?	N/A
	Road X Slope (%)	N/A	N/A	Clear Space to XWalk (in)	N/A
N/A	Any Obstructions?	N/A	N/A	Storm Grate/Utility Hazard?	N/A
	Obstruction Type			Storm Grate/Utility Type	
		N/A			N/A
			Yes	Surface Condition? (G/P)	Good

Possible Solutions:

**Remove & Replace Entire Ramp.**
