Access Compliance Report

Public Rights-of-Way (Curb Ramps)

Intersection ID: 6889	Main Street: GRIERS GROVE RD	Cross Street: PLUMSTEAD RD	Location: W
ADA ID: 815B9CFE159B	Ramp Type: Para	Initial Pass/Fail: Fail	Overall Compliance: No
Codes/Mitigation Info/Possible Solution		Field Measurements/Component Compliance

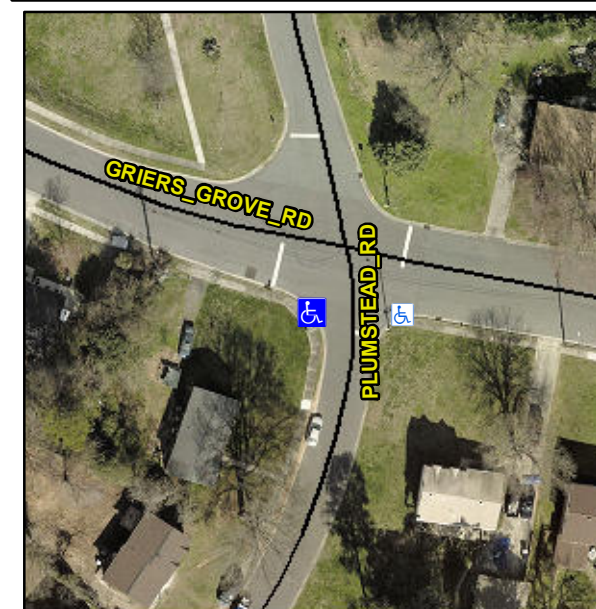
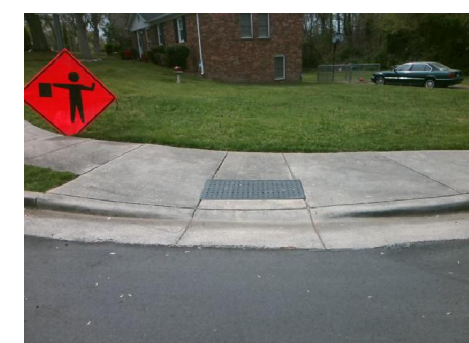
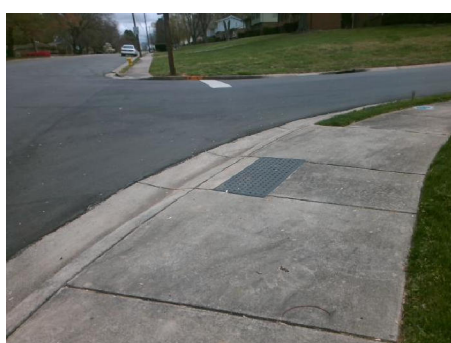
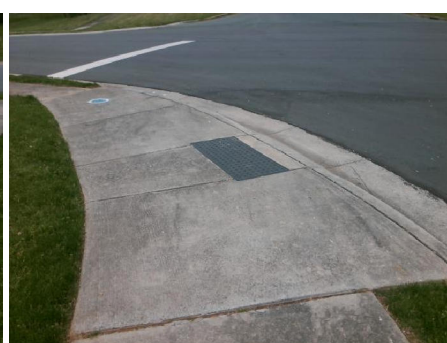
RT RP < 5%

R304.3.2, R304.5.3

Compliance	Description	Data	Compliance	Description	Data
N/A	Ramp Length LT (in)	56.5	N/A	Ramp Length RT (in)	58.0
Yes	Ramp Width LT (in)	60.0	Yes	Ramp Width RT (in)	76.0
No	Ramp Slope LT (%)	10.2	Yes	Ramp Slope RT (%)	2.1
No	Ramp XSlope LT (%)	3.6	Yes	Ramp XSlope RT (%)	1.3
N/A	Landing Length (in)	N/A	N/A	DWS Provided?	N/A
N/A	Landing Width (in)	N/A	N/A	DWS Contrast?	N/A
N/A	Landing Slope (%)	N/A	N/A	DWS Length (in)	N/A
N/A	Landing X Slope (%)	N/A	N/A	DWS Full Width?	N/A
N/A	Landing Curb? (Y/N)	N/A	N/A	DWS Offset (in)	N/A
N/A	Shared Landing?	N/A			
N/A	Gutter Ponding?	N/A	N/A	Gutter Slope (%)	N/A
N/A	Gutter Lip Ht (in)	N/A	N/A	Gutter X Slope (%)	N/A
N/A	Painted X Walk1?	No	N/A	Painted X Walk2?	N/A
	X Walk 1 Direction	To E		X Walk 2 Direction	N/A
N/A	X Walk 1 Width (in)	N/A	N/A	X Walk 2 Width (in)	N/A
	X Walk 1 Slope (%)	5.8		X Walk 2 Slope (%)	N/A
	X Walk 1 X Slope (%)	1.4		X Walk 2 X Slope (%)	N/A
N/A	Ramp inside XWalk1?	N/A	N/A	Ramp inside XWalk2?	N/A

Road Slope (%)	N/A	N/A	Clear Space?	N/A
	Road X Slope (%)	N/A	N/A	Clear Space to XWalk (in)	N/A
N/A	Any Obstructions?	N/A	N/A	Storm Grate/Utility Hazard?	N/A
	Obstruction Type			Storm Grate/Utility Type	
		N/A			N/A
			Yes	Surface Condition? (G/P)	Good
			N/A	Curb Slope (%)	28.2

Remove & Replace Entire Ramp.
