Access Compliance Report

Public Rights-of-Way

(Curb Ramps)

Intersection ID: 9440	Main Street: BRADFORD_DR	Cross Street: EDGEWOOD_RD	Location:	N
ADA ID: 8160B204F621	Ramp Type: Perp	Initial Pass/Fail: Fail	Overall Compliance: No	Severity Score: 13.75

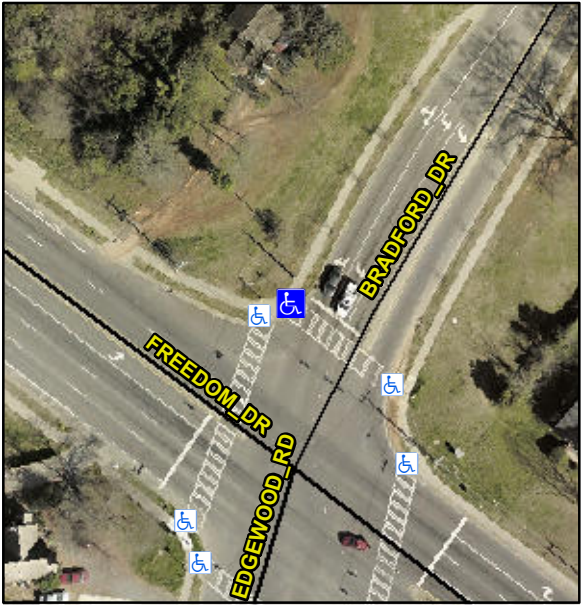
Possible Solutions:		Compliance	Description	Data
	Remove & Replace Entire Ramp.		N/A	Ramp Length (in)	60.0
			Yes	Ramp Width (in)	48.0
			N/A	Flare Type LT	N/A
			N/A	Flare Slope LT (%)	N/A
			N/A	Flare Traversable LT?	N/A
			N/A	Landing Length (in)	N/A
			N/A	Landing Width (in)	N/A
			N/A	Landing Slope (%)	N/A
			N/A	Landing X Slope (%)	N/A
<p>Surveyor Notes:</p> <p>N/A</p> <p>PROW/ADA:</p> <p>Not Found, R304.2.2, R304.5.3</p>			N/A	Flare Type RT	N/A
			N/A	Flare Slope RT (%)	N/A
			N/A	Flare Traversable RT?	N/A
			N/A	DWS Provided?	N/A
			N/A	DWS Contrast?	N/A
			N/A	DWS Length (in)	N/A
			N/A	DWS Full Width?	N/A
			N/A	DWS Offset (in)	N/A
			N/A	Shared Landing?	N/A
			N/A	Gutter Ponding?	N/A
			N/A	Gutter Lip Ht (in)	N/A
			N/A	Painted X Walk1?	Yes
				X Walk 1 Direction	To SE
			N/A	X Walk 1 Width (in)	116.0
				X Walk 1 Slope (%)	3.4

X Walk 1 X Slope (%)	0.9
			N/A	Ramp inside XWalk1?	Yes
			N/A	Road Slope (%)	N/A
			N/A	Road X Slope (%)	N/A
			N/A	Any Obstructions?	N/A
				Obstruction Type	
Total Cost:		\$ 1850.00			
			N/A		N/A
			Yes	Surface Condition? (G/P)	Good
