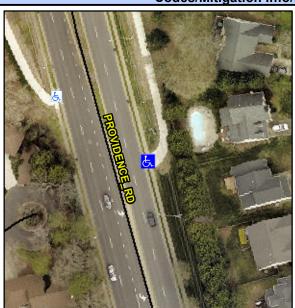
Access Compliance Report Public Rights-of-Way (Curb Ramps)

Total Cost: 1850.00

the state of the s
Street 1 Name	PROVIDENCE RD
Stop Condition-Street 2	None
Street 2 Name	N/A
Ston Condition-Street 1	N/A
