# Access Compliance Report

## Public Rights-of-Way

### (Curb Ramps)

| Intersection ID: 46951 | Main Street: PROVIDENCE_RD | Cross Street: OLDE_WHITE_LN | Location: SW |

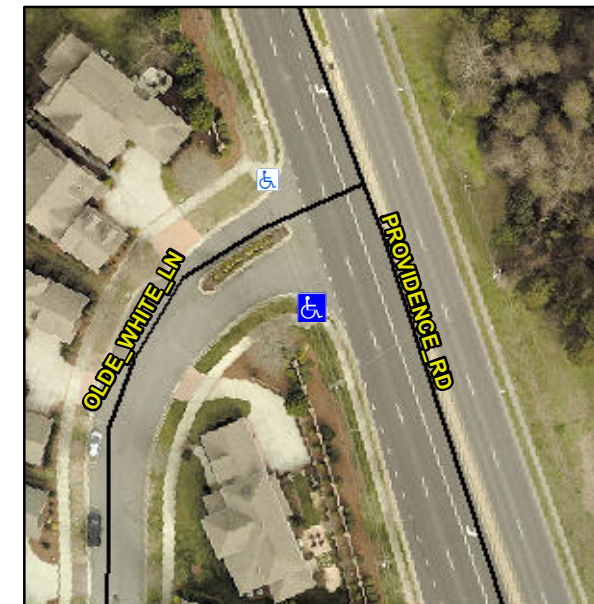
| ADA ID: 81759591BE0E | Ramp Type: PerpDiag | Initial Pass/Fail: Fail | Overall Compliance: No |
| | | | Severity Score: 33.75 |

| Compliance | Description | Data | Compliance | Description | Data |
|---|---|---|---|---|---|
| N/A | Ramp Length (in) | 74.0 | Yes | Ramp Slope (%) | 5.6 |
| No | Ramp Width (in) | 47.0 | No | Ramp XSlope (%) | 12.1 |

**Remove & Replace Curb Ramp With Two New Directional Ramps or Equivalent.**

**R304.5.1, R304.5.3**
