# Access Compliance Report

## Public Rights-of-Way

### (Curb Ramps)

Intersection ID: 8208	Main Street: BROOKSHIRE_BV	Cross Street: N_CRIGLER_ST	Location: SE
ADA ID: 81798CABBB86	Ramp Type: Perp	Initial Pass/Fail: Fail	Overall Compliance: No
Codes/Mitigation Info/Possible Solution		Field Measurements/Component Compliance	
Severity Score: 10

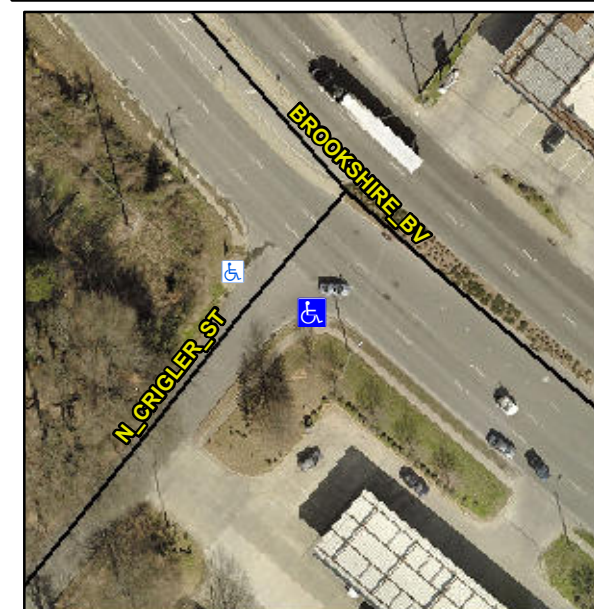
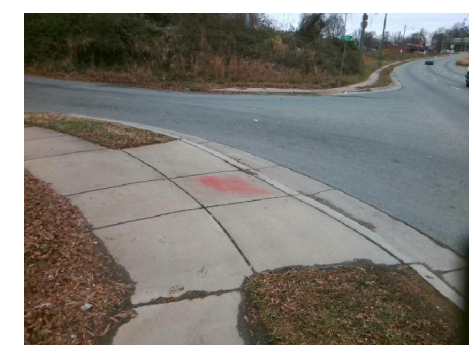
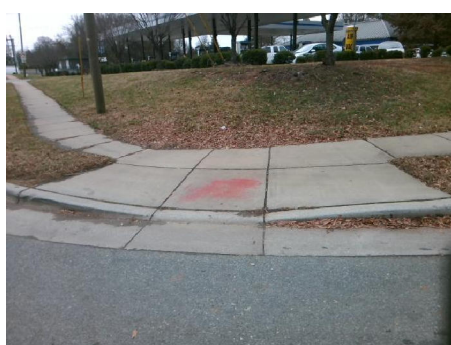
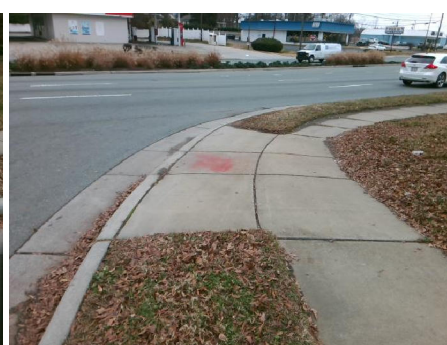
**Not Found, R304.5.1, R304.5.3**

Compliance	Description	Data	Compliance	Description	Data
N/A	Ramp Length (in)	48.0	Yes	Ramp Slope (%)	7.9
No	Ramp Width (in)	41.0	No	Ramp XSlope (%)	3.8
N/A	Flare Type LT	N/A	N/A	Flare Type RT	N/A
N/A	Flare Slope LT (%)	N/A	N/A	Flare Slope RT (%)	N/A
N/A	Flare Traversable LT?	N/A	N/A	Flare Traversable RT?	N/A
N/A	Landing Length (in)	N/A	N/A	DWS Provided?	N/A
N/A	Landing Width (in)	N/A	N/A	DWS Contrast?	N/A
N/A	Landing Slope (%)	N/A	N/A	DWS Length (in)	N/A
N/A	Landing X Slope (%)	N/A	N/A	DWS Full Width?	N/A
N/A	Landing Curb? (Y/N)	N/A	N/A	DWS Offset (in)	N/A
N/A	Shared Landing?	N/A			
N/A	Gutter Ponding?	N/A	N/A	Gutter Slope (%)	N/A
N/A	Gutter Lip Ht (in)	N/A	N/A	Gutter X Slope (%)	N/A
N/A	Painted X Walk1?	No	N/A	Painted X Walk2?	N/A
	X Walk 1 Direction	To NW		X Walk 2 Direction	N/A
N/A	X Walk 1 Width (in)	N/A	N/A	X Walk 2 Width (in)	N/A
	X Walk 1 Slope (%)	0.3		X Walk 2 Slope (%)	N/A
	X Walk 1 X Slope (%)	3.6		X Walk 2 X Slope (%)	N/A

N/A	Ramp inside XWalk1?	N/A	N/A	Ramp inside XWalk2?	N/A
	Road Slope (%)	N/A	N/A	Clear Space?	N/A
	Road X Slope (%)	N/A	N/A	Clear Space to XWalk (in)	N/A
N/A	Any Obstructions?	N/A	N/A	Storm Grate/Utility Hazard?	N/A
	Obstruction Type			Storm Grate/Utility Type	
		N/A			N/A
			Yes	Surface Condition? (G/P)	Good

**Remove & Replace Entire Ramp.**
