Access Compliance Report

Public Rights-of-Way

(Curb Ramps)

Intersection ID: 42366	Main Street: CARDINALS_NEST_DR	Cross Street: HERON_GLEN_DR	Location: E
ADA ID: 817A7C18517B	Ramp Type: BlendTrans1	Initial Pass/Fail: Pass	Overall Compliance: No
		Severity Score: 10

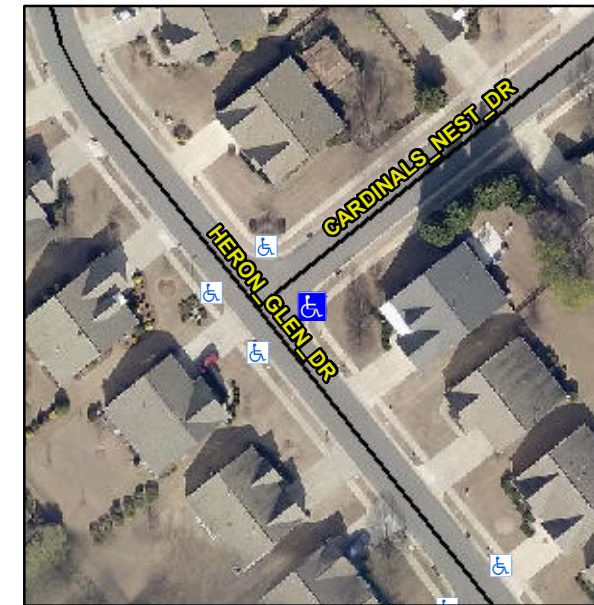
Surveyor Notes:

N/A

PROW/ADA:

Not Found, R304.2.1, R304.2.2-Perp, R304.3.2-Para, R304.5.3, R305

Compliance	Description	Data	Compliance	Description	Data
N/A	Ramp Length (in)	48.0	Yes	BlendTrans Slope (%)	2.3
Yes	Ramp Width (in)	48.0	Yes	BlendTrans XSlope (%)	1.7
N/A	Flare Type LT	Sloped	N/A	Flare Type RT	Sloped
N/A	Flare Slope LT (%)	8.5	N/A	Flare Slope RT (%)	0.4
N/A	Flare Traversable LT?	No	N/A	Flare Traversable RT?	No
No	Landing Length (in)	47.0	No	DWS Provided?	No
Yes	Landing Width (in)	48.0	N/A	DWS Contrast?	No
No	Landing Slope (%)	4.2	N/A	DWS Length (in)	N/A
No	Landing X Slope (%)	5.1	N/A	DWS Full Width?	No
N/A	Landing Curb? (Y/N)	No	N/A	DWS Offset (in)	N/A
N/A	Shared Landing?	No			
Yes	Gutter Ponding?	No	Yes	Gutter Slope (%)	4.7
Yes	Gutter Lip Ht (in)	0.0	Yes	Gutter X Slope (%)	0.6
N/A	Painted X Walk1?	No	N/A	Painted X Walk2?	No
	X Walk 1 Direction	To NW		X Walk 2 Direction	To SW
	X Walk 1 Width (in)	N/A		X Walk 2 Width (in)	N/A
	X Walk 1 Slope (%)	3.0		X Walk 2 Slope (%)	3.0
	X Walk 1 X Slope (%)	3.6		X Walk 2 X Slope (%)	2.5

N/A	Ramp inside XWalk1?	N/A	N/A	Ramp inside XWalk2?	N/A
	Road Slope (%)	4.2		Clear Space?	Yes
	Road X Slope (%)	0.8	N/A	Clear Space to XWalk (in)	N/A
Yes	Any Obstructions?	No	Yes	Storm Grate/Utility Hazard?	No
	Obstruction Type			Storm Grate/Utility Type	
		N/A			N/A
			Yes	Surface Condition? (G/P)	Good
			No	Curb Slope (%)	14.7

Possible Solutions:

Remove & Replace Curb Ramp With Two New Directional Ramps or Equivalent.
