## Access Compliance Report Public Rights-of-Way (Curb Ramps)

Intersection ID: 18391	ntersection ID: 18391 Main Street: LYNBROOK_DR					Cross Street: RAMA_RD				
ADA ID: 81825D7963A7				Initial Pass/Fail: Fail Overall Compliance: No				o Severity Score:	21.25	
Codes/Mitigation Info/Possible Solution				Field Measurements/Component Compliance						
		Possible Solutions:		Compliance Description			Data Compliance Description		Data	
		Remove & Replace Curb Ramp	With	N/A	Ramp Length (in)	70.0	No	Ramp Slope (%)	9.6

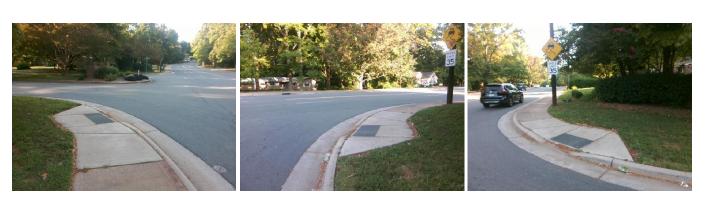
10.2		Two New Directional Ramps or		No	Ramp Width (in)	47.5	Yes	Ramp XSlope (%)	0.3	
AND		Equivalent.		N/A	Flare Type LT	N/A	N/A	Flare Type RT	N/A	
				N/A	Flare Slope LT (%)	N/A	N/A	Flare Slope RT (%)	N/A	
10				N/A	Flare Traversable LT?	N/A	N/A	Flare Traversable RT?	N/A	
				N/A	Landing Length (in)	N/A	N/A	DWS Provided?	N/A	
		Surveyor Notes:		N/A	Landing Width (in)	N/A	N/A	DWS Contrast?	N/A	
<u>म</u> स्		N/A		N/A	Landing Slope (%)	N/A	N/A	DWS Length (in)	N/A	
				N/A	Landing X Slope (%)	N/A	N/A	DWS Full Width?	N/A	
LYNBROOK	DR			N/A	Landing Curb? (Y/N)	N/A	N/A	DWS Offset (in)	N/A	
	A REAL PROPERTY OF A REAL PROPER			N/A	Shared Landing?	N/A		ζ, γ		
A CONTRACTOR OF A CONTRACTOR OFTA CONTRACTOR O		PROW/ADA:		N/A	Gutter Ponding?	N/A	N/A	Gutter Slope (%)	N/A	
k starting		Not Found, R304.5.1, R304.2.2		N/A	Gutter Lip Ht (in)	N/A	N/A	Gutter X Slope (%)	N/A	
the second se	No. And			N/A	Painted X Walk1?	No	N/A	Painted X Walk2?	No

X Walk 1 Direction	To SW		X Walk 2 Direction	To S	
				N/A	X Walk 1 Width (in)	N/A	N/A	X Walk 2 Width (in)	N/A	
Street 1 Name	RAMA RD	•			X Walk 1 Slope (%)	3.7		X Walk 2 Slope (%)	0.2	
Stop Condition-Street 2	None				X Walk 1 X Slope (%)	0.7		X Walk 2 X Slope (%)	2.0	
Street 2 Name	LYNBROOK DR			N/A	Ramp inside XWalk1?	N/A	N/A	Ramp inside XWalk2?	N/A	
Stop Condition-Street 1	StopSign				Road Slope (%)	0.8	N/A	Clear Space?	N/A	
	etopoign				Road X Slope (%)	2.0	N/A	Clear Space to XWalk (in)	N/A	
				N/A	Any Obstructions?	2.0 N/A		Storm Grate/Utility Hazard?	N/A	
		Total Cost: \$	3200.00	1975	Obstruction Type			Storm Grate/Utility Type	11/5	
		φ	5200.00			N/A		Storm Oraco, Ouncy Type	N/A	
						IN/A			IN/A
