## Access Compliance Report Public Rights-of-Way (Curb Ramps)

Intersection ID: 47016 Main Street: TRIBUNE\_DR Cross Street: GLAZER\_VALLEY\_CT Location: N

ADA ID: 81832958FADD Ramp Type: PerpDiag Initial Pass/Fail: Fail Overall Compliance: No Severity Score: 28.75

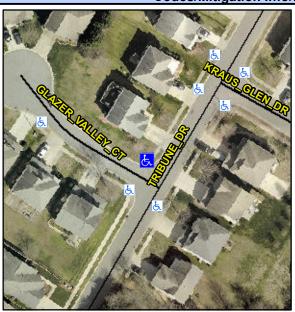
Compliance Description Data Compliance Description Data 45.5 No N/A Ramp Length (in) Ramp Slope (%) 9.1 No Ramp XSlope (%) Yes Ramp Width (in) 48.0 3.1 N/A N/A Flare Type LT N/A Flare Type RT N/A N/A N/A N/A Flare Slope RT (%) N/A Flare Slope LT (%) N/A Flare Traversable LT? N/A N/A Flare Traversable RT? N/A N/A Landing Length (in) N/A N/A DWS Provided? N/A N/A Landing Width (in) N/A N/A **DWS Contrast?** N/A N/A N/A N/A Landing Slope (%) DWS Length (in) N/A N/A Landing X Slope (%) N/A N/A DWS Full Width? N/A N/A Landing Curb? (Y/N) N/A N/A DWS Offset (in) N/A N/A N/A Shared Landing? N/A **Gutter Ponding?** N/A N/A Gutter Slope (%) N/A N/A Gutter Lip Ht (in) N/A N/A Gutter X Slope (%) N/A N/A Painted X Walk1? No N/A Painted X Walk2? No X Walk 1 Direction To SW X Walk 2 Direction To SE N/A N/A X Walk 1 Width (in) X Walk 2 Width (in) N/A X Walk 1 Slope (%) 5.8 X Walk 2 Slope (%) 0.9 X Walk 1 X Slope (%) 1.1 X Walk 2 X Slope (%) 5.9 N/A N/A N/A Ramp inside XWalk2? N/A Ramp inside XWalk1? Road Slope (%) 2.8 N/A Clear Space? N/A N/A Road X Slope (%) 6.9 Clear Space to XWalk (in) N/A N/A N/A N/A Any Obstructions? Storm Grate/Utility Hazard? N/A **Obstruction Type** Storm Grate/Utility Type N/A N/A

Poor

Remove & Replace Curb Ramp With Two New Directional Ramps or Equivalent.

Not Found, R304.2.2, R304.5.3, R302.7
