Access Compliance Report

Public Rights-of-Way

(Curb Ramps)

Intersection ID: N/A	Main Street: E 7TH ST	Cross Street: N/A	Location: W
ADA ID: 81879E23474F	Ramp Type: Perp	Initial Pass/Fail: Fail	Overall Compliance: No
Codes/Mitigation Info/Possible Solution		Field Measurements/Component Compliance	
Severity Score: 12.5

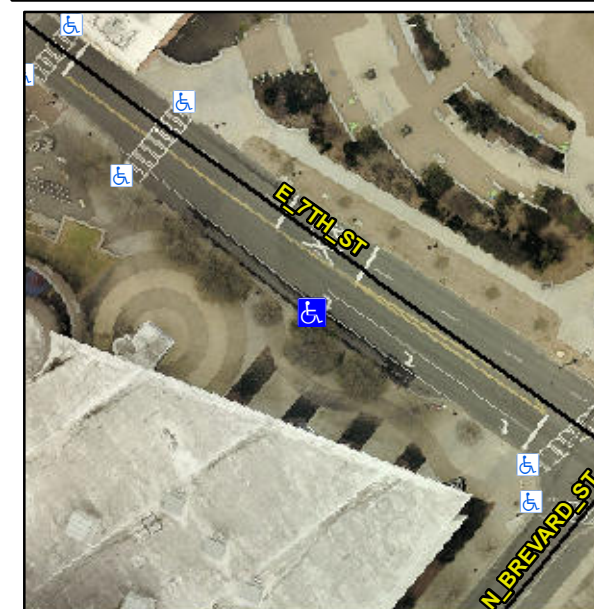
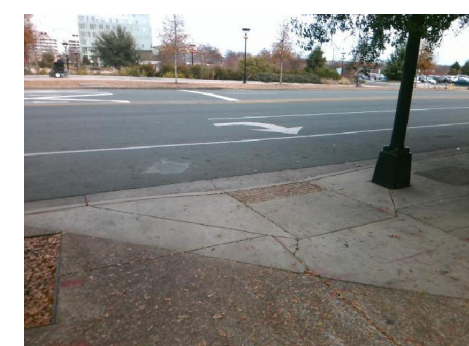
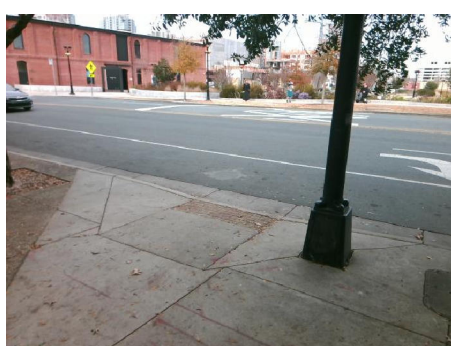
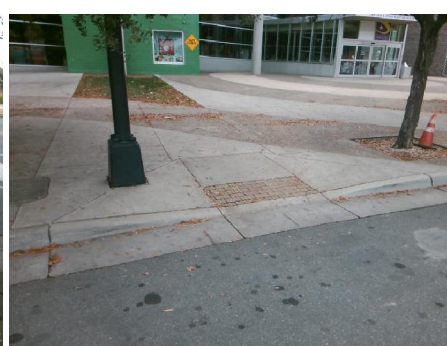
Not Found, R304.2.2

Compliance	Description	Data	Compliance	Description	Data
N/A	Ramp Length (in)	72.0	No	Ramp Slope (%)	8.6
Yes	Ramp Width (in)	58.0	Yes	Ramp XSlope (%)	1.2
N/A	Flare Type LT	N/A	N/A	Flare Type RT	N/A
N/A	Flare Slope LT (%)	N/A	N/A	Flare Slope RT (%)	N/A
N/A	Flare Traversable LT?	No	N/A	Flare Traversable RT?	No
N/A	Landing Length (in)	N/A	N/A	DWS Provided?	N/A
N/A	Landing Width (in)	N/A	N/A	DWS Contrast?	N/A
N/A	Landing Slope (%)	N/A	N/A	DWS Length (in)	N/A
N/A	Landing X Slope (%)	N/A	N/A	DWS Full Width?	N/A
N/A	Landing Curb? (Y/N)	N/A	N/A	DWS Offset (in)	N/A
N/A	Shared Landing?	N/A			
N/A	Gutter Ponding?	N/A	N/A	Gutter Slope (%)	N/A
N/A	Gutter Lip Ht (in)	N/A	N/A	Gutter X Slope (%)	N/A
N/A	Painted X Walk1?	No	N/A	Painted X Walk2?	N/A
	X Walk 1 Direction	To E		X Walk 2 Direction	N/A
N/A	X Walk 1 Width (in)	N/A	N/A	X Walk 2 Width (in)	N/A
	X Walk 1 Slope (%)	3.3		X Walk 2 Slope (%)	N/A
	X Walk 1 X Slope (%)	0.7		X Walk 2 X Slope (%)	N/A

N/A	Ramp inside XWalk1?	N/A	N/A	Ramp inside XWalk2?	N/A
	Road Slope (%)	N/A	N/A	Clear Space?	N/A
	Road X Slope (%)	N/A	N/A	Clear Space to XWalk (in)	N/A
N/A	Any Obstructions?	N/A	N/A	Storm Grate/Utility Hazard?	N/A
	Obstruction Type			Storm Grate/Utility Type	
		N/A			N/A
			Yes	Surface Condition? (G/P)	Good

Remove & Replace Entire Ramp.

Total Cost: \$ 1850.00
