# Access Compliance Report

## Public Rights-of-Way

### (Curb Ramps)

| Intersection ID: 10168 | Main Street: ROZZELLES_FERRY_RD | Cross Street: S_GARDNER_AV | Location: NE |

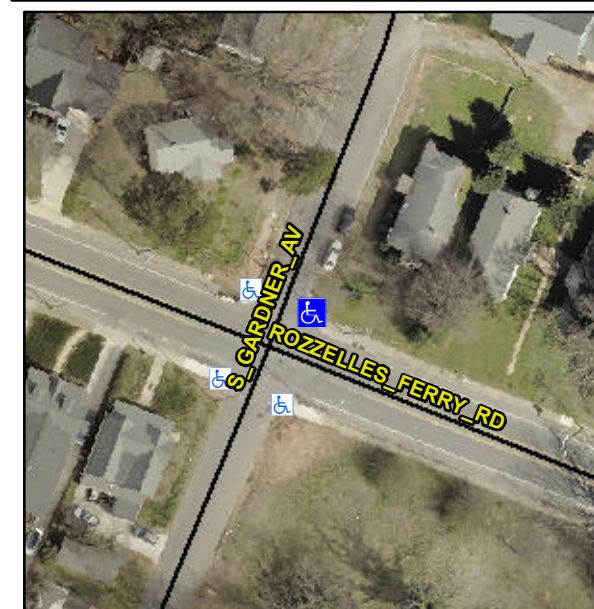
| Compliance | Description | Data | Compliance | Description | Data |
|---|---|---|---|---|---|
| N/A | Ramp Length (in) | 60.5 | Yes | Ramp Slope (%) | 7.0 |
| Yes | Ramp Width (in) | 48.0 | No | Ramp XSlope (%) | 3.8 |
| No | Landing Length (in) | N/A | Yes | DWS Provided? | Yes |
| No | Landing Width (in) | N/A | Yes | DWS Contrast? | Yes |
| No | Landing Slope (%) | N/A | Yes | DWS Length (in) | 24.0 |
| No | Landing X Slope (%) | N/A | Yes | DWS Full Width? | Yes |
| N/A | Landing Curb? (Y/N) | No | No | DWS Offset (in) | 3.0 |
| Yes | Gutter Lip Ht (in) | 0.0 | No | Gutter X Slope (%) | 3.0 |

**Remove & Replace Curb Ramp With Two New Directional Ramps or Equivalent. Remove & Replace Gutter.**

**Not Found, R304.5.3, R304.2.1, R304.2.2-Perp, R304.3.2-Para, R305.2**
