Access Compliance Report

Public Rights-of-Way

(Curb Ramps)

Intersection ID: 13829	Main Street: E_MOREHEAD_ST	Cross Street: DILWORTH_RD	Location: E
ADA ID: 819F8D2C699D	Ramp Type: PerpDiag	Initial Pass/Fail: Fail	Overall Compliance: No
Codes/Mitigation Info/Possible Solution		Field Measurements/Component Compliance	
Severity Score: 21.25

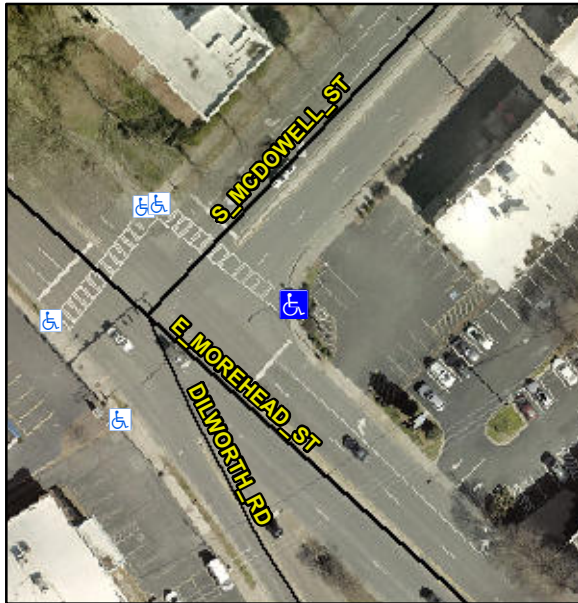
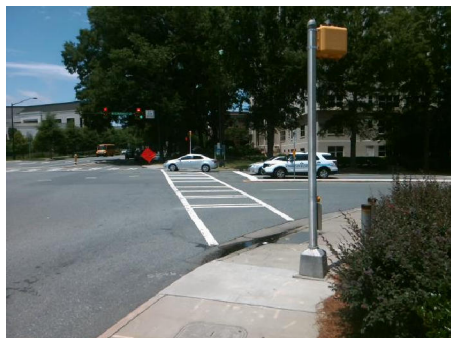
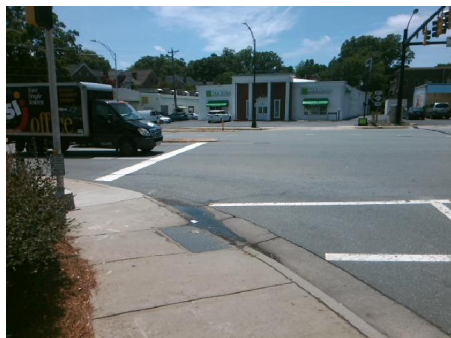
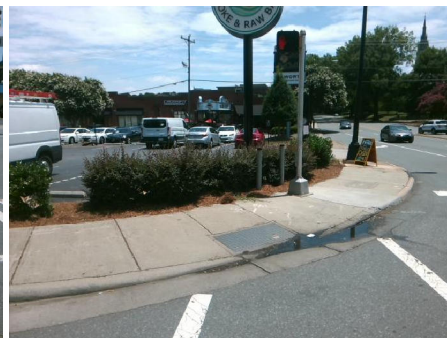
R304.5.1, R304.2.2

Compliance	Description	Data	Compliance	Description	Data
N/A	Ramp Length (in)	80.0	No	Ramp Slope (%)	8.8
No	Ramp Width (in)	45.0	Yes	Ramp XSlope (%)	1.1
N/A	Flare Type LT	N/A	N/A	Flare Type RT	N/A
N/A	Flare Slope LT (%)	N/A	N/A	Flare Slope RT (%)	N/A
N/A	Flare Traversable LT?	N/A	N/A	Flare Traversable RT?	N/A
N/A	Landing Length (in)	N/A	N/A	DWS Provided?	N/A
N/A	Landing Width (in)	N/A	N/A	DWS Contrast?	N/A
N/A	Landing Slope (%)	N/A	N/A	DWS Length (in)	N/A
N/A	Landing X Slope (%)	N/A	N/A	DWS Full Width?	N/A
N/A	Landing Curb? (Y/N)	N/A	N/A	DWS Offset (in)	N/A
N/A	Shared Landing?	N/A			
N/A	Gutter Ponding?	Yes	N/A	Gutter Slope (%)	N/A
N/A	Gutter Lip Ht (in)	N/A	N/A	Gutter X Slope (%)	N/A
N/A	Painted X Walk1?	Yes	N/A	Painted X Walk2?	No
	X Walk 1 Direction	To NW		X Walk 2 Direction	To W
N/A	X Walk 1 Width (in)	92.0	N/A	X Walk 2 Width (in)	N/A
	X Walk 1 Slope (%)	4.7		X Walk 2 Slope (%)	2.9
	X Walk 1 X Slope (%)	1.5		X Walk 2 X Slope (%)	2.6

N/A	Ramp inside XWalk1?	Yes	N/A	Ramp inside XWalk2?	N/A
	Road Slope (%)	1.3	N/A	Clear Space?	N/A
	Road X Slope (%)	3.5	N/A	Clear Space to XWalk (in)	N/A
N/A	Any Obstructions?	N/A	N/A	Storm Grate/Utility Hazard?	N/A
	Obstruction Type			Storm Grate/Utility Type	
		N/A			N/A
		Yes		Surface Condition? (G/P)	Good

Remove & Replace Curb Ramp With Two New Directional Ramps or Equivalent.
